Municipal Utilities/Public Works Commission

Water Infrastructure Condition/Seismic/Structural
Assessment

Summary of Findings, Conclusions, and
Recommendations

Richard Brady & Associates

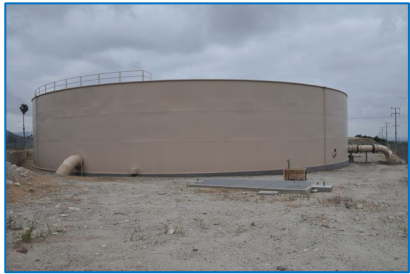
Agate Reservoir

Grade: C

-Excessive Shell Stress

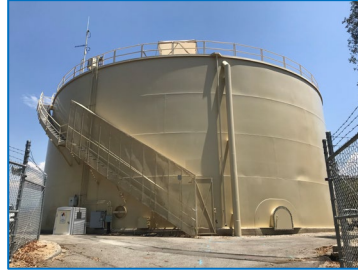
Crafton Hills Reservoir

Grade: C

-Excessive Shell Stress
-Insufficient Freeboard

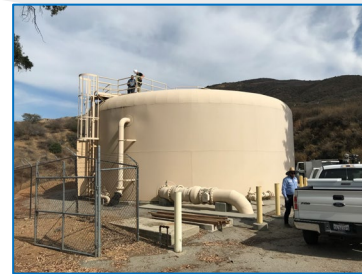
Mill Creek East

Grade: B

-Seismic Overturning
-Insufficient Freeboard

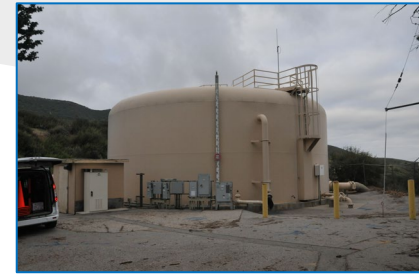
Mill Creek West

Grade: B

-Seismic Overturning
-Insufficient Freeboard

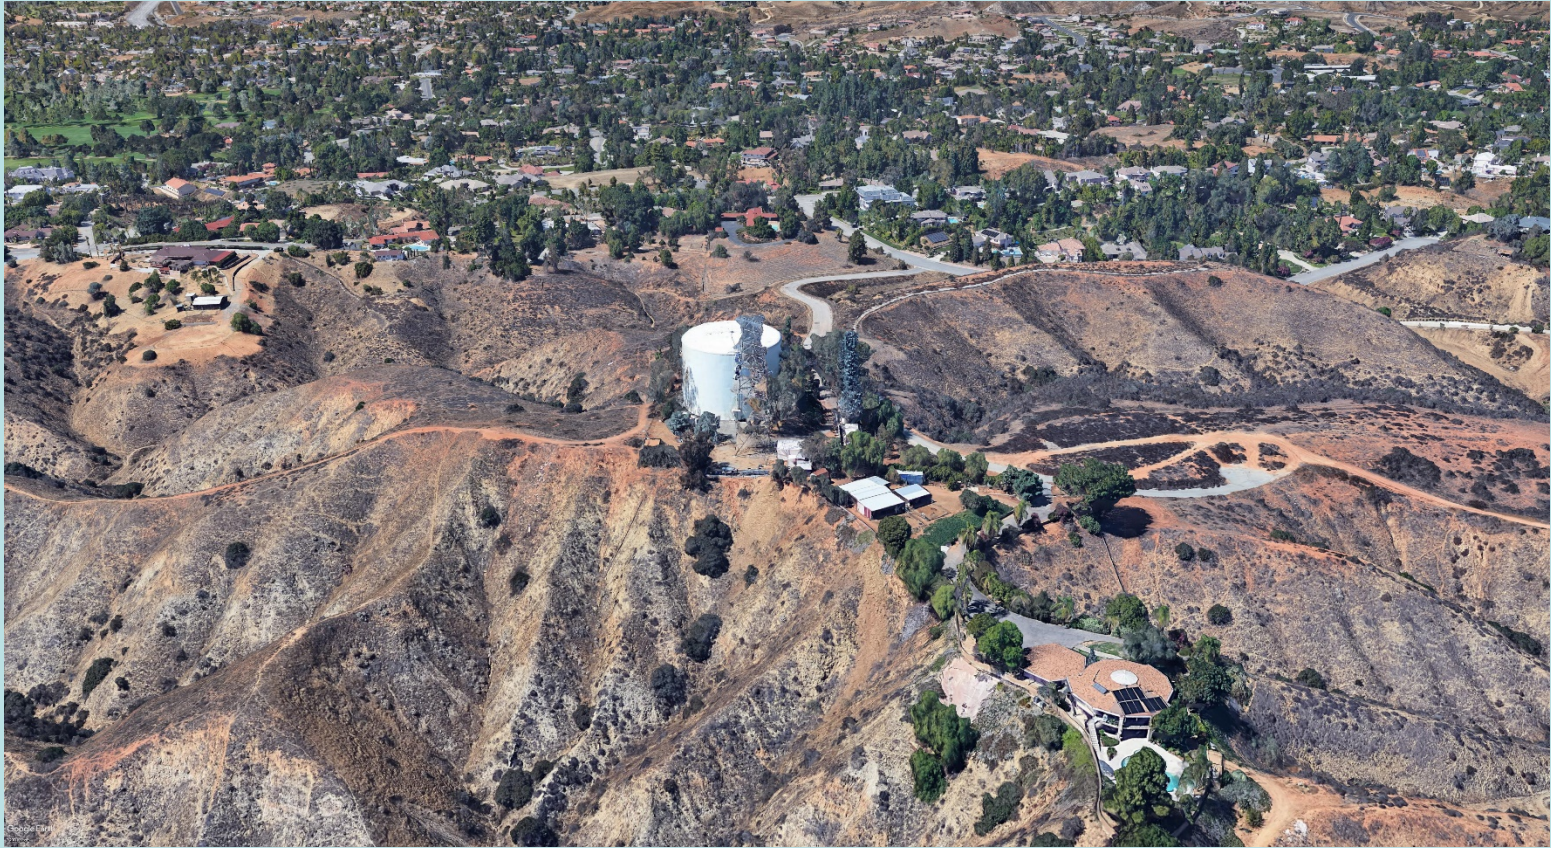
The many problems with Sunset Reservoir...

- All 12 of the City's steel tanks do not meet current seismic codes
- As a result, high water elevations need to be lowered
- Lower elevations = loss of storage = 6 MG
- Sunset needs immediate replacement

1. 750,000 gallon temporary Sunset tank
2. New Sunset Reservoir, size TBD
3. Second inlet pipeline to the Tate WTP
4. New 60-inch pipe leaving Hinckley to achieve CT, then remove Agate baffles
5. Seismic retrofit at 10 MG Highland Reservoir
6. New Fifth Avenue Reservoir and Pump Station
7. Improve 2.4 MG Margarita or replace storage elsewhere
8. Lower operating levels at all steel tanks
9. No work needed at Dearborn or Country Club Reservoirs
10. New building around Ward Way

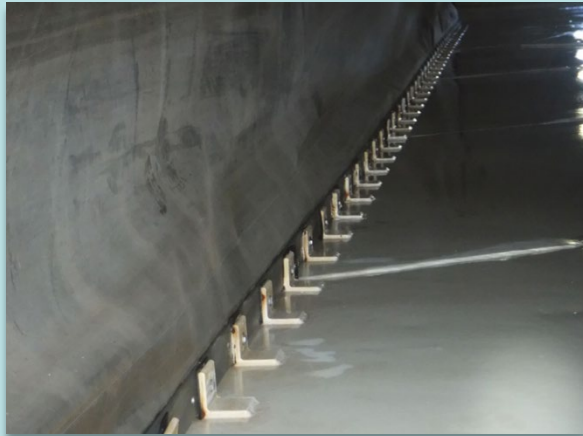
Hypalon curtains shown anchored to the floor

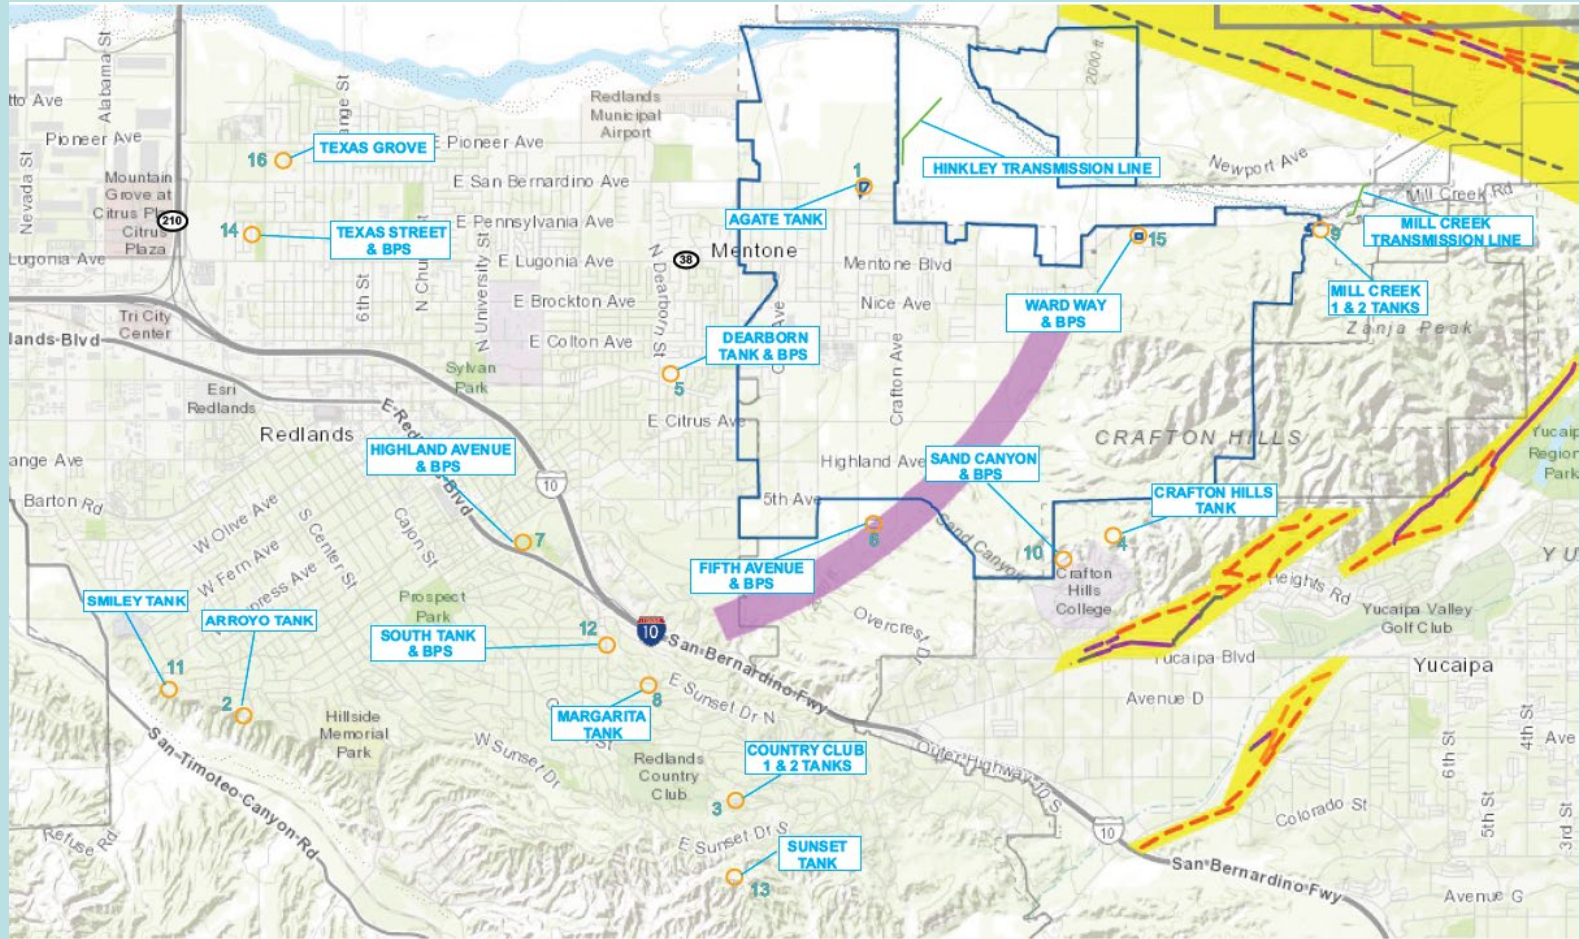
Surface Fault Rupture Potential Impacts the 5 MG Fifth Avenue Reservoir
