GEOTECHNICAL ENGINEERING INVESTIGATION
THE NEIGHBORHOODS AT LUGONIA VILLAGE
NORTHWEST CORNER OF WEST LUGONIA AVENUE
AND KARON STREET
REDLANDS, CALIFORNIA
Project Number: H02901.01

**Subject: Geotechnical Engineering Investigation
 The Neighborhoods at Lugonia Village
 Northwest Corner of West Lugonia Avenue and Karon Street
 Redlands, California**

**Geotechnical Engineering Investigation
The Neighborhoods at Lugonia Village
NWC of West Lugonia Avenue and Karon Street, Redlands, California
February 11, 2022**

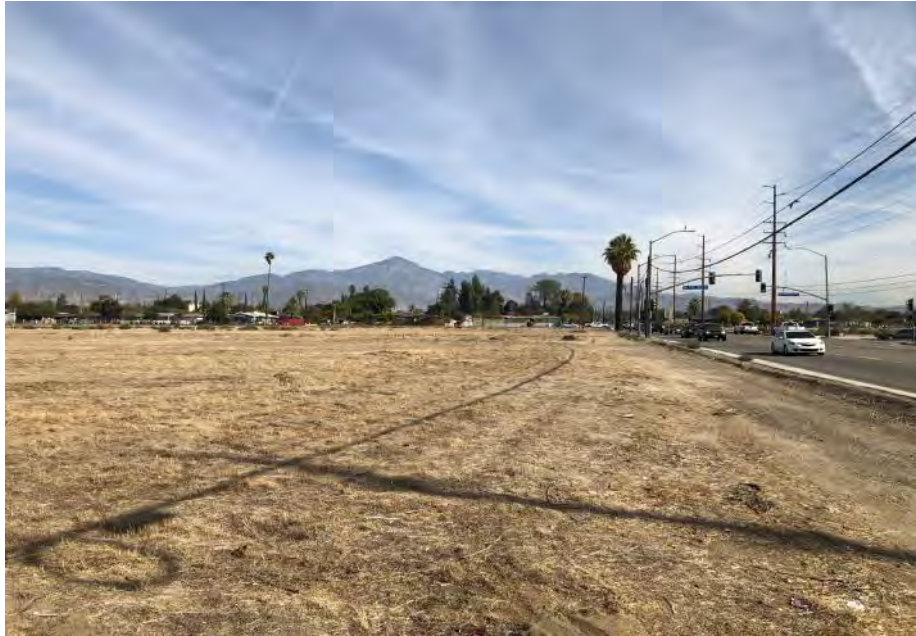
Photograph No. 1: Viewing east along south side of site adjacent to West Lugonia Avenue

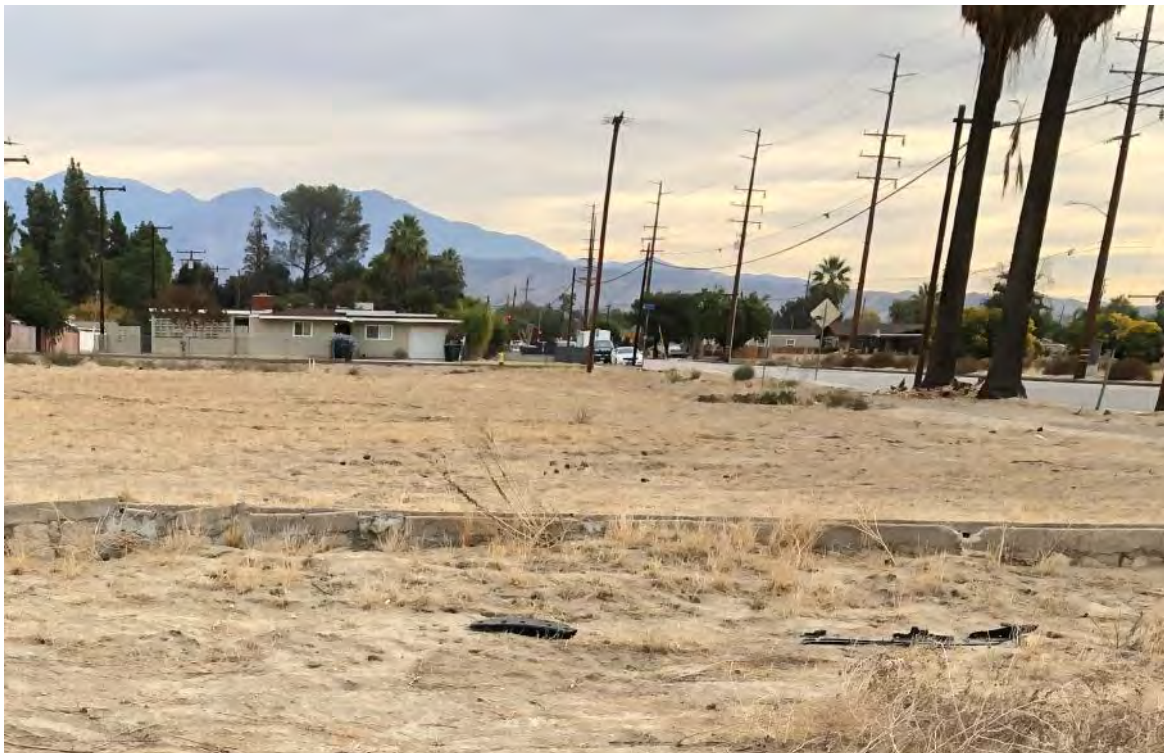
Photograph No. 2: Viewing east at U-shaped concrete structure (electrical easement) that trends in a north-south orientation across the south-central portion of the site

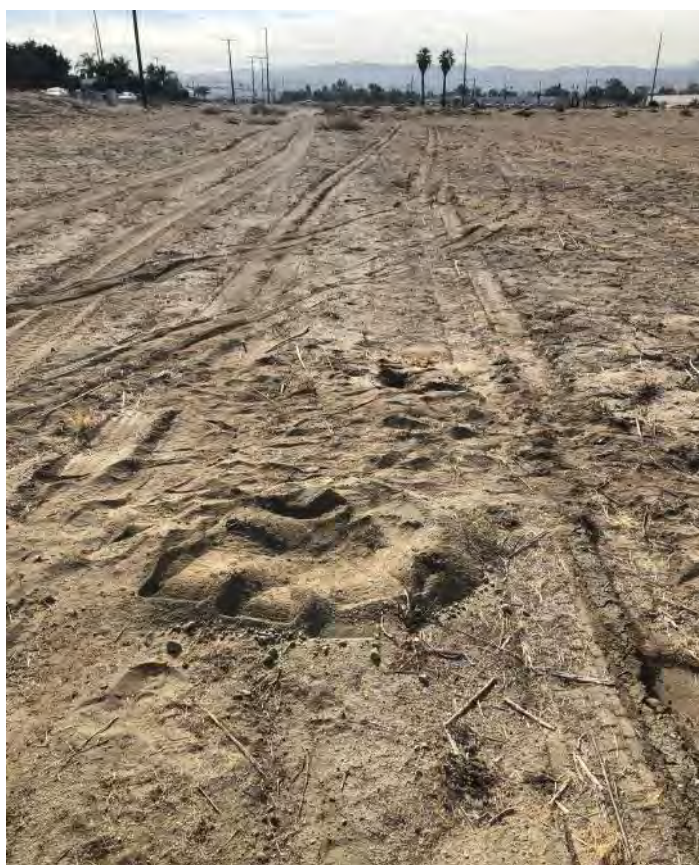
Photograph No. 4: Viewing south along east side of site; west-facing slope adjacent to Karon Street shown in background on left side of picture

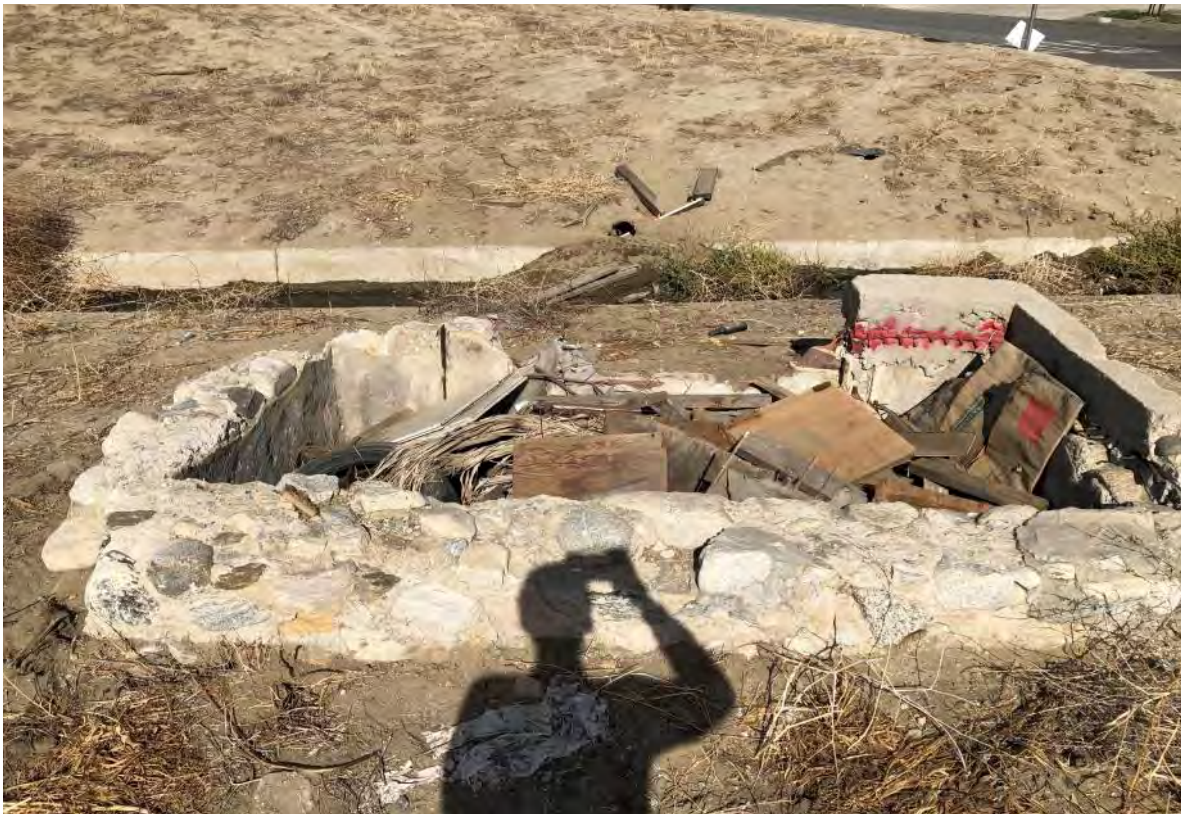
Photograph No. 6: Rectangular-shaped structure in northeast corner of site and U-shaped concrete drainage structure in background trending east-west along center line of future extension of Pennsylvania Avenue

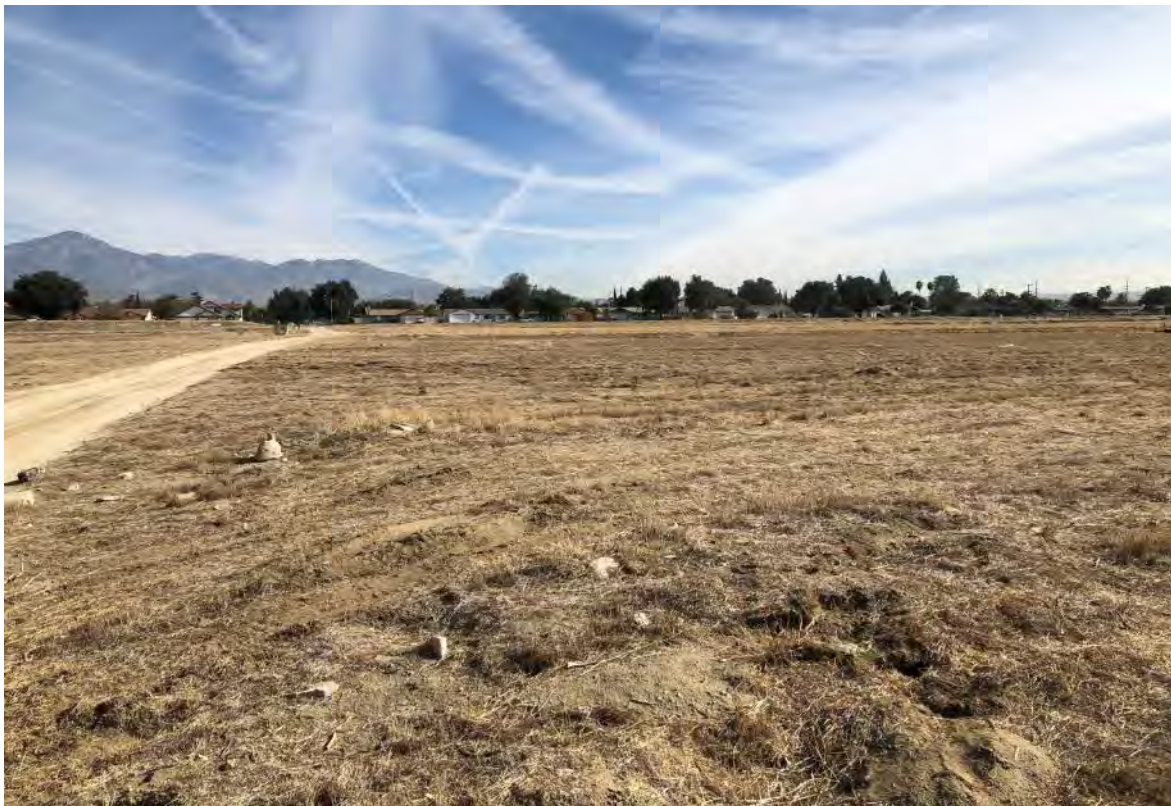
Photograph No. 8: Viewing east from northwest corner of site showing scattered concrete debris in foreground

At the time of our investigation, the site was generally vacant land covered by scattered dead grasses and weeds. Some scattered concrete debris was also noted throughout the site. Where existing vegetation and landscaping is present, these areas should be stripped of all vegetation and top soil, and removal of vegetation should remove all roots greater than ¼ inch in diameter. Debris such as concrete debris should be removed from the site and not mixed with on-site soils.

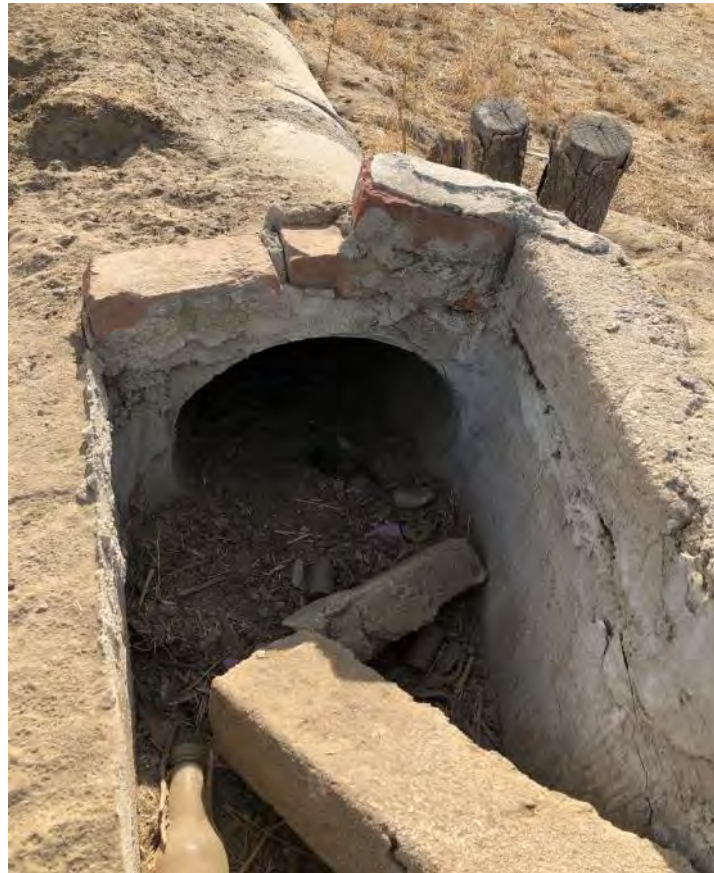
Photograph No. 10: Close-up of concrete drainage structure on west side of site

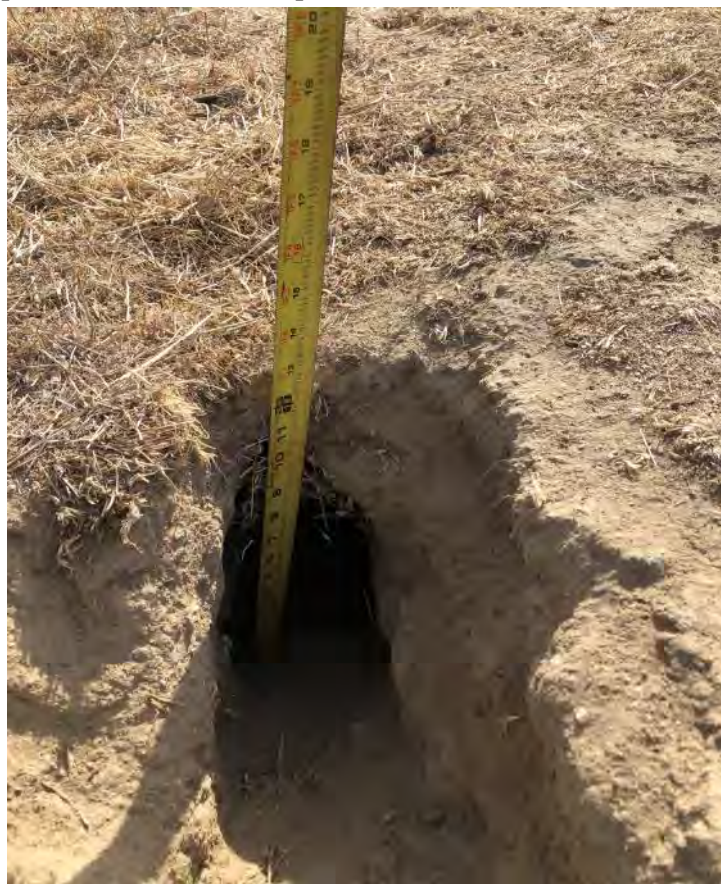
Rodent burrows were also noted throughout the site, some of which extended about 12 inches, and deeper, below site grade.

Photograph No.12: Thirteen-inch deep rodent burrow on west side of site

Drainage/irrigation structures were noted on the north and west sides of the site. A debris pit was noted in the northeastern corner of the site, and a dry well was noted in the southwestern portion of the site. In addition, an electrical easement exists at the site. These on-site features should be completely removed and any piping or underground utilities (if any) should be removed from the site and not mixed with soils to be used as engineered fill. Recycled materials including asphalt, concrete and brick should not be mixed in with soils to be used as engineered fill below buildings; however, these materials may be processed to less than 6 inches in size and mixed in with soils to be used as engineered fill outside of building areas. Rodent burrows were also noted throughout the site, some of which extended about 12 inches in depth. The rodent burrows should be over-excavated until undisturbed soils are encountered.

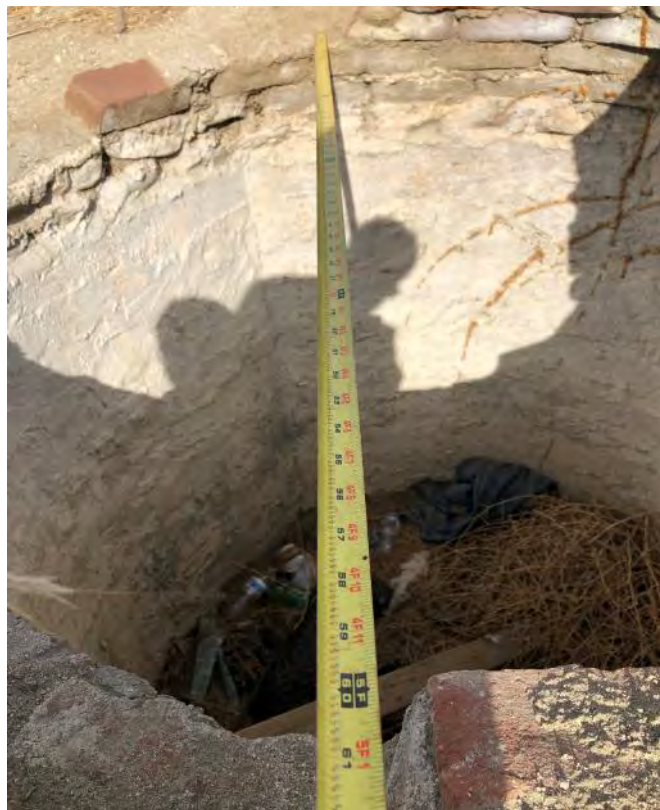
An open cylindrical excavation (thought to be a dry well) was noted in the southwestern portion of the site. The dry well was about 5 feet in diameter and the sides of the structure was lined with brick

and concrete. The dry well was filled with concrete debris; thus, the depth of the hole could not be determined. The depth to the top of the debris was about 4.5 to 5 feet below grade. An approximate 12 to 18-inch diameter pipe was noted as extending perpendicular away from the shaft near the bottom just above the debris. A smaller, approximate 4-inch diameter pipe was noted as extending perpendicular away from the dry well near the top of the well. It is assumed that the dry well may be associated with some of the past improvements noted at the site.

Photograph No. 14: Open cylindrical excavation (shaft) in southwest portion of site is about 5 feet in diameter
