City of Redlands Historic Architectural Design Guidelines

January 4, 2021

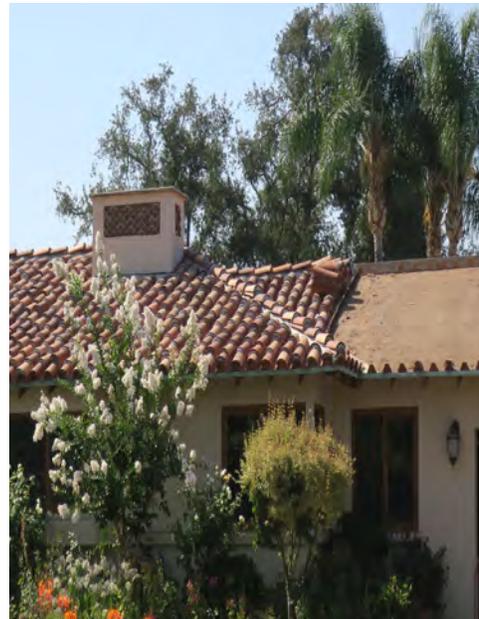
New roof tiles or shingles should match the material, size, profile, and color of the historic roof as closely as possible.

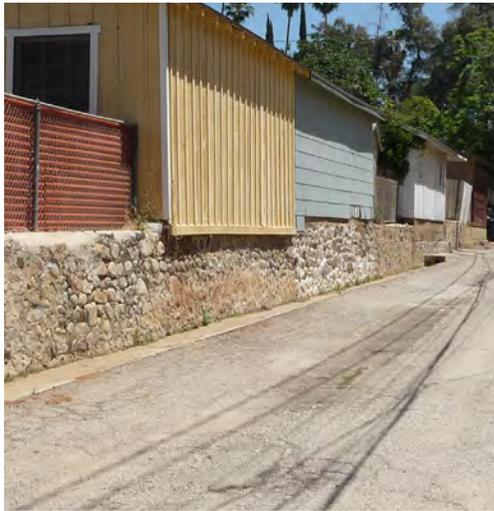
Arroyo stone foundations are an important architectural feature of many historic houses in Redlands and should be preserved.

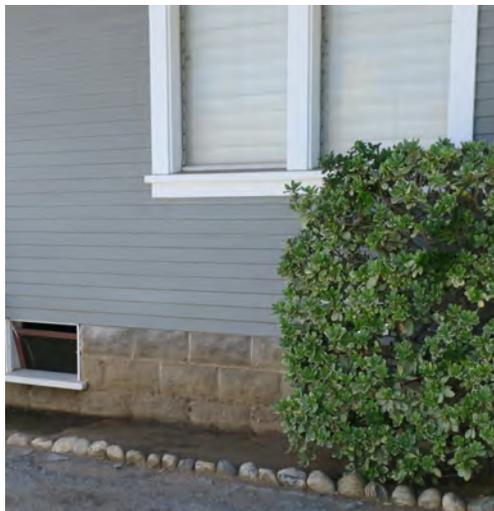
Routine maintenance, such as cleaning and repointing, is important to prolong the life of a historic foundation.

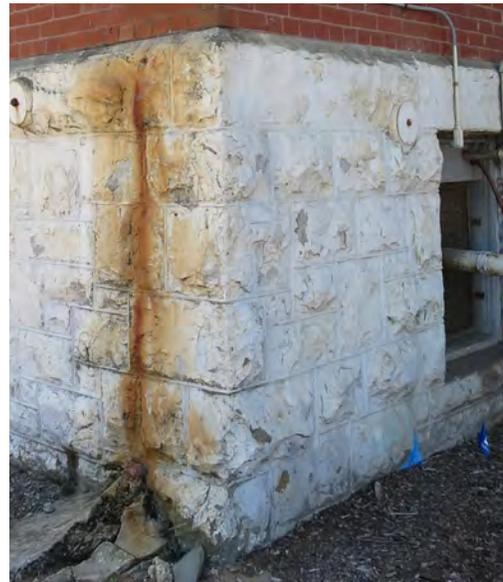
A cast stone foundation that is in need of repair.

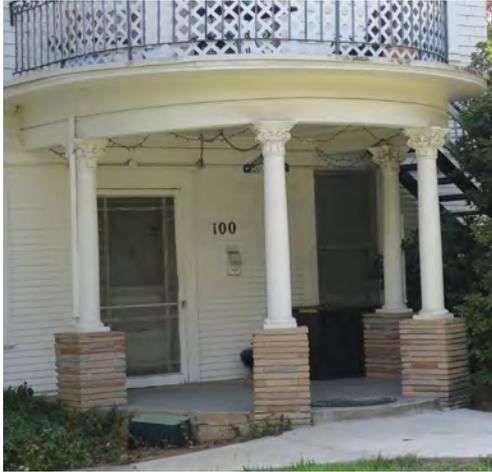
Restore non-historic porch components, such as these piers supporting original porch columns, to their original condition.

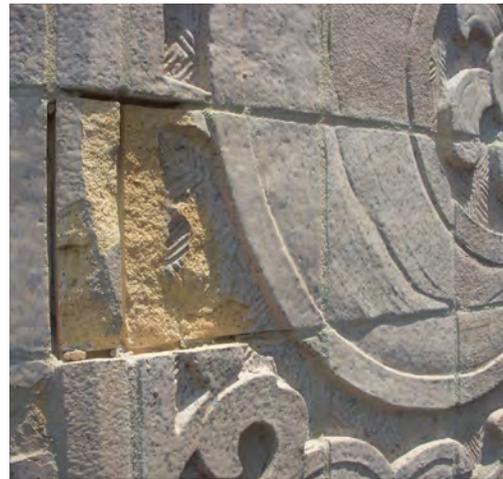
Damaged terra cotta detail.

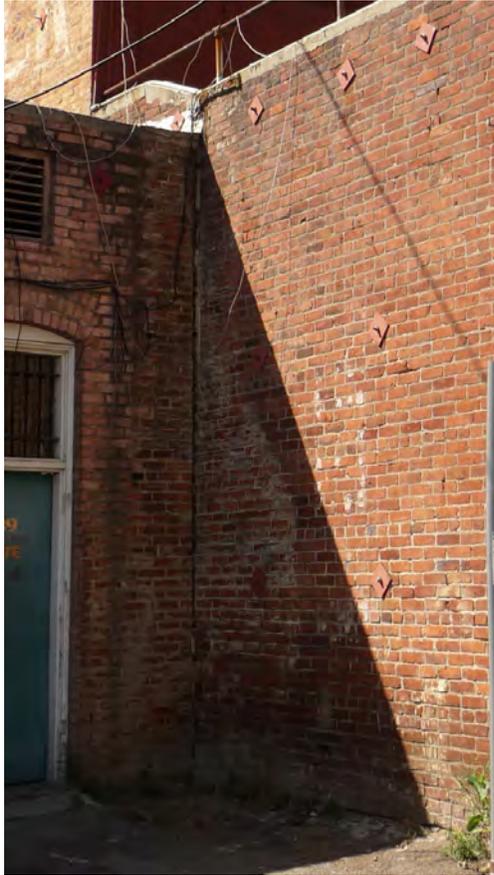
Efflorescence on a historic brick wall.

Efflorescence is water-soluble salts that have leached out of the masonry, evaporated, and deposited on the surface, usually as a white, powdery substance. The salt crystals expand as the water is evaporated, leading to surface damage, and in some cases, sub-surface damage (sub-florescence).

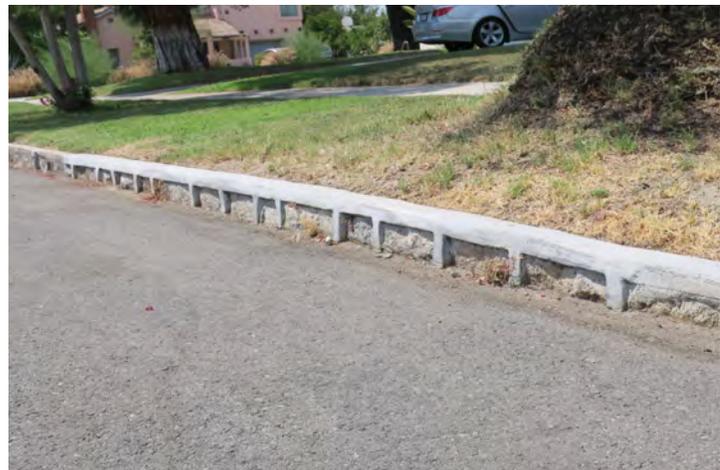
Inappropriate concrete repairs to cut stone curbing.

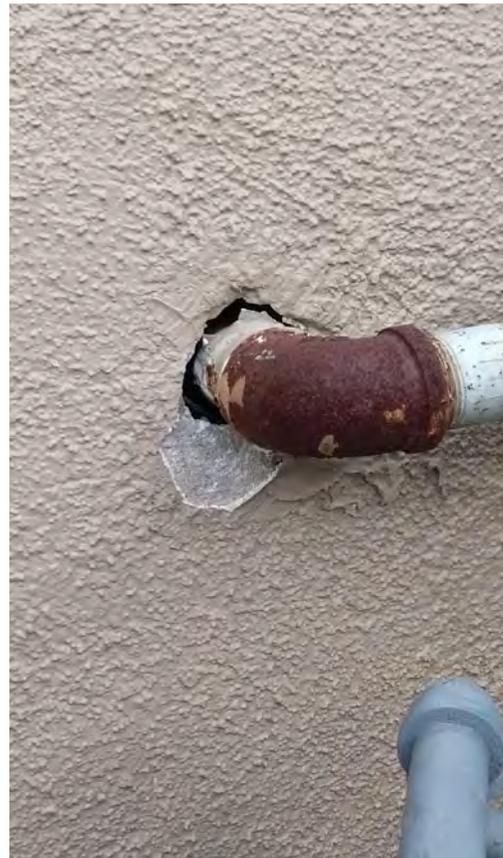
Void and spalling around stucco wall pipe intrusion.

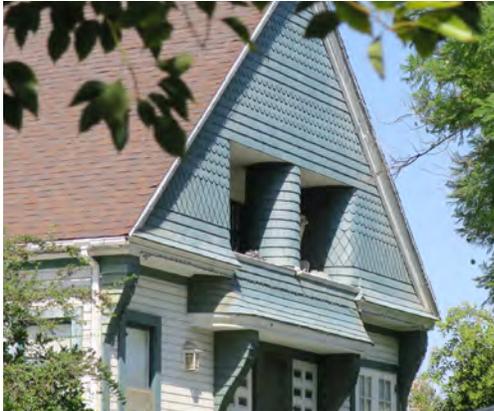
Wood shingle wall cladding.

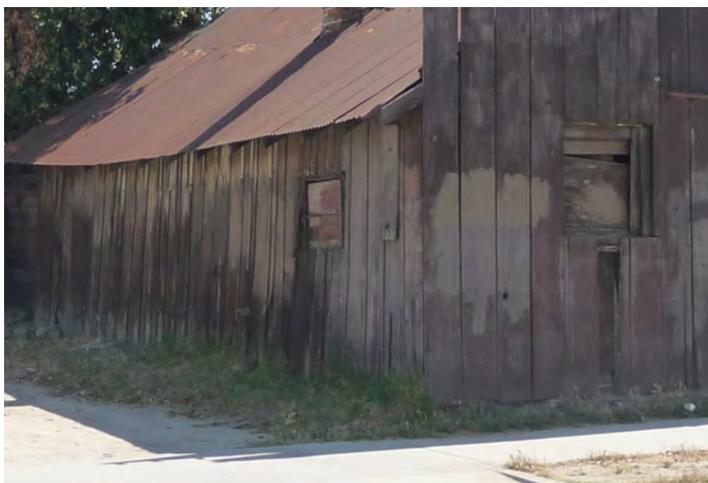
Direct contact with the ground can lead to wood decay.

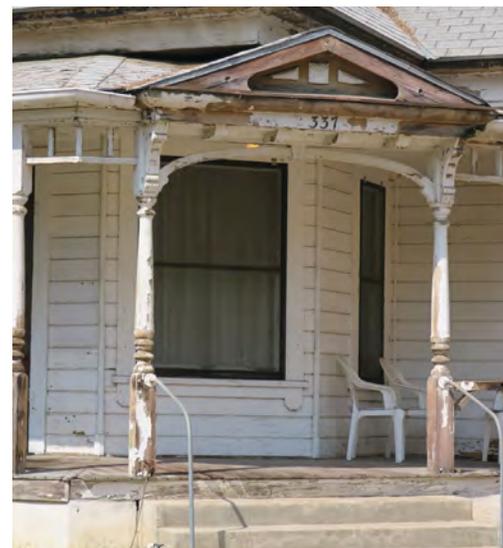
Deteriorated woodwork at a porch.

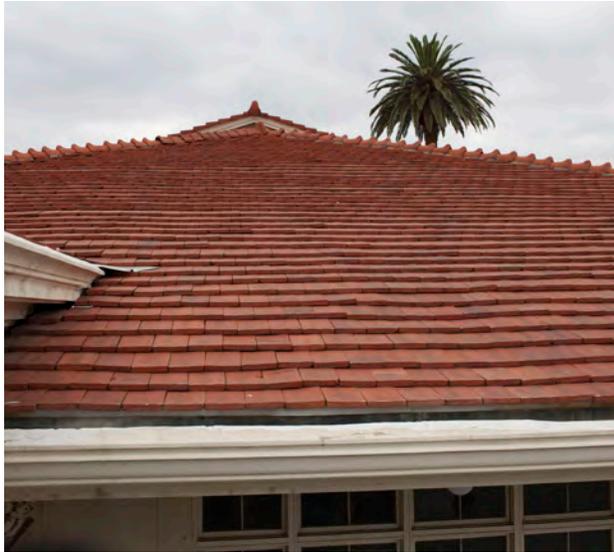
Clay tile (terra cotta) roofing on the Santa Fe Depot.

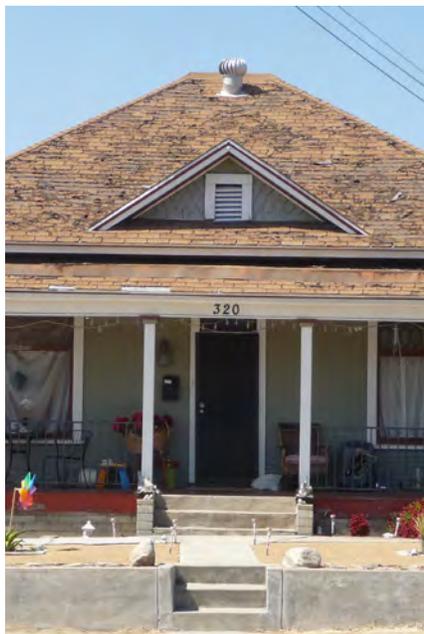
Deteriorated asphalt shingle roofing on the former Harbert Residence (1907).

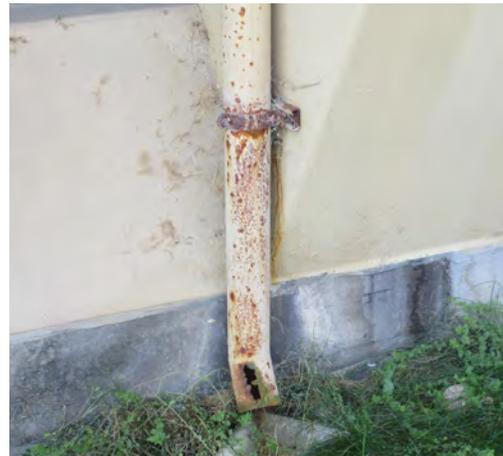
Corroded downspout.

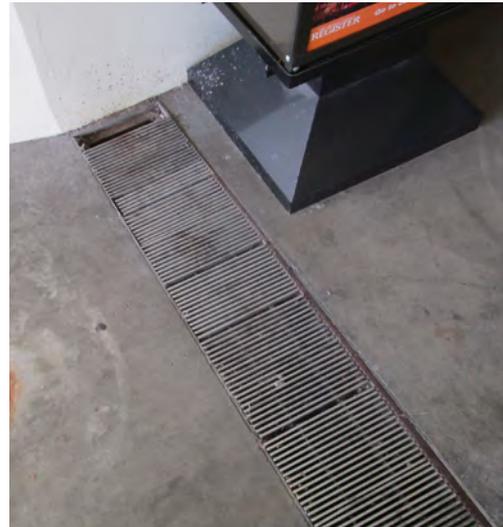
Drain with uneven grate panels.

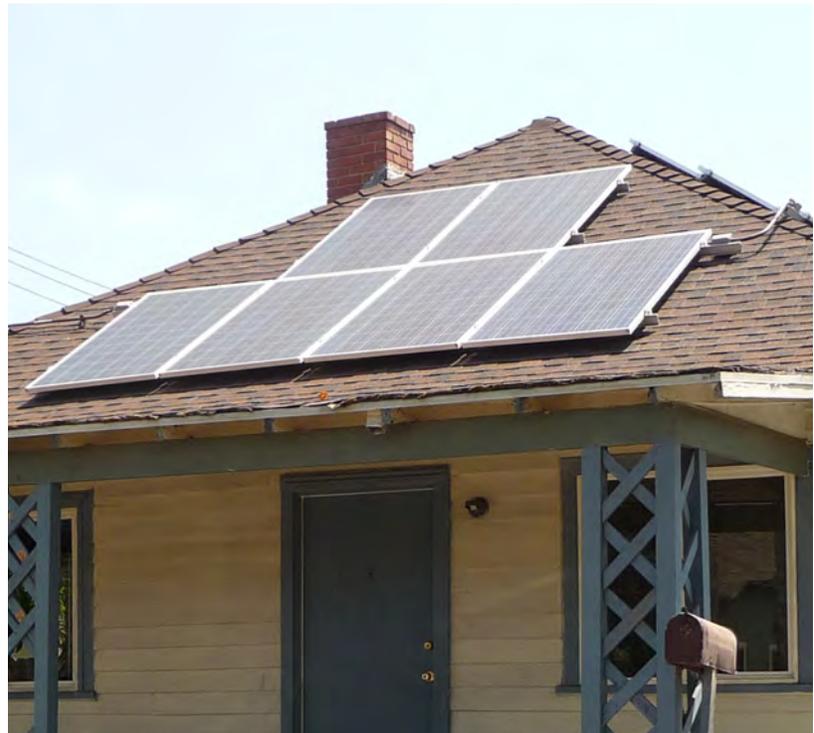
Solar panels on a composition shingle roof.

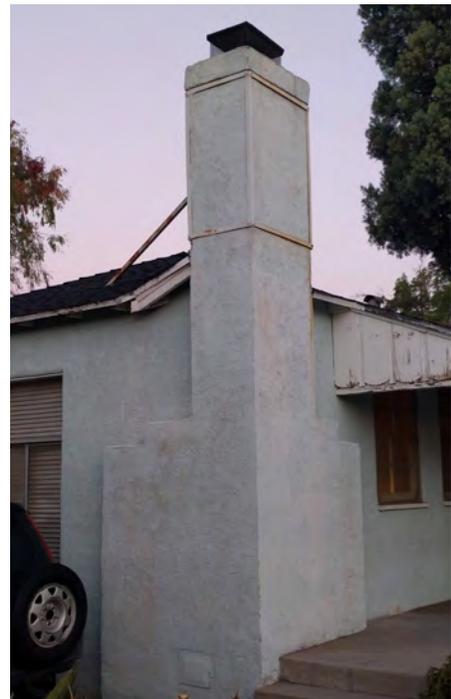
Brace or reinforce chimneys.

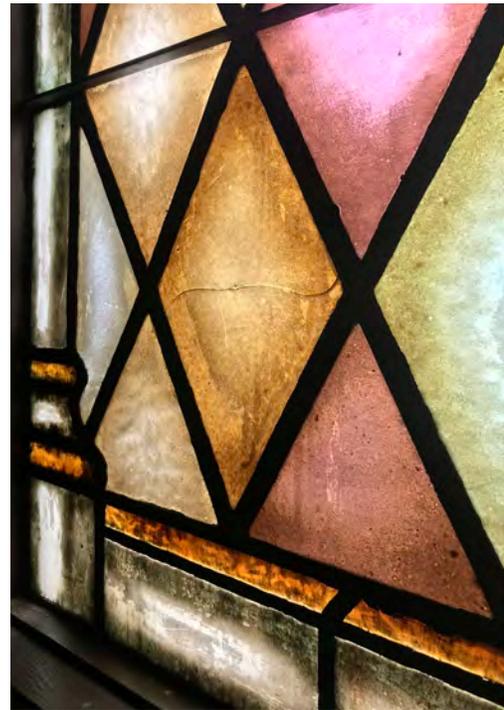
Cracked glazing in a stained glass window.

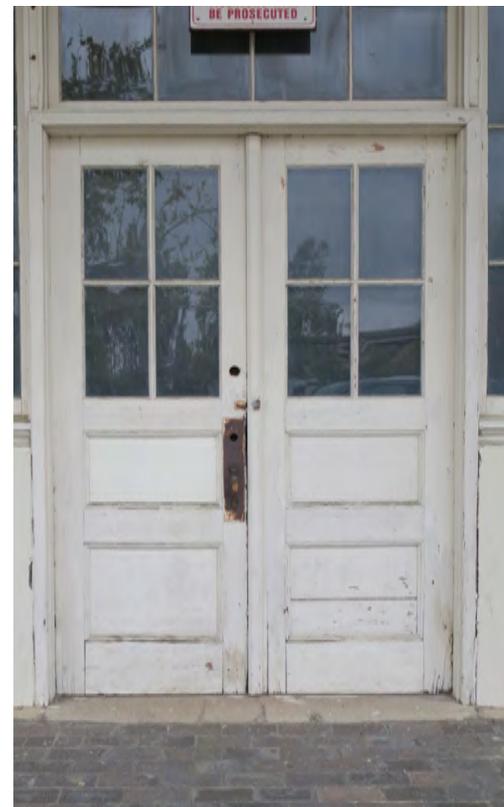
Weathered doors with corroded and missing hardware.

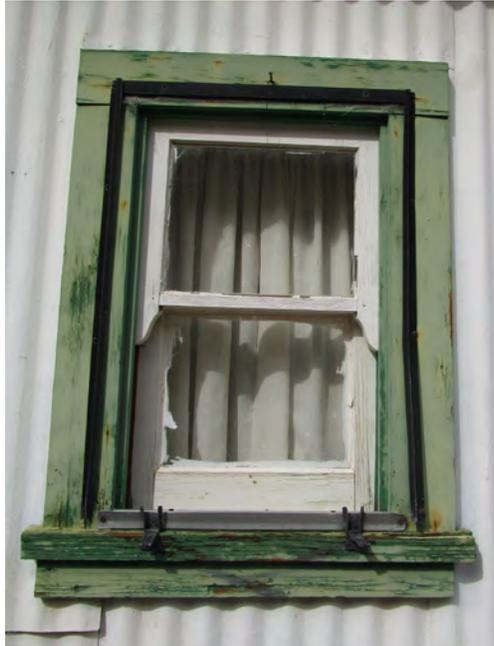
Weathered and racked window needing repair.

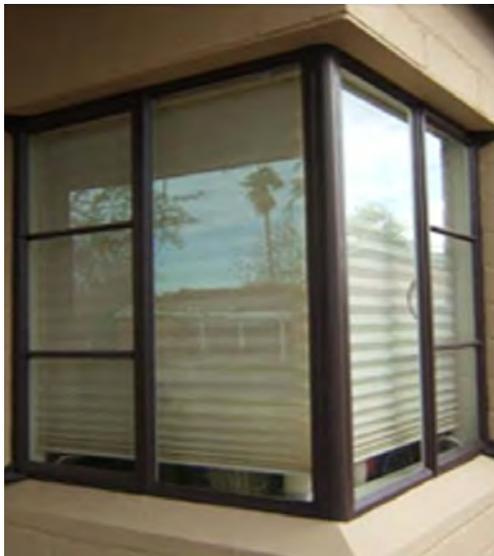
Retrofitting original windows with historically compatible, low-e glass is a way to achieve greater energy efficiency. (Photo, City of Phoenix Planning and Development Department, Historic Preservation Office, 2018.)

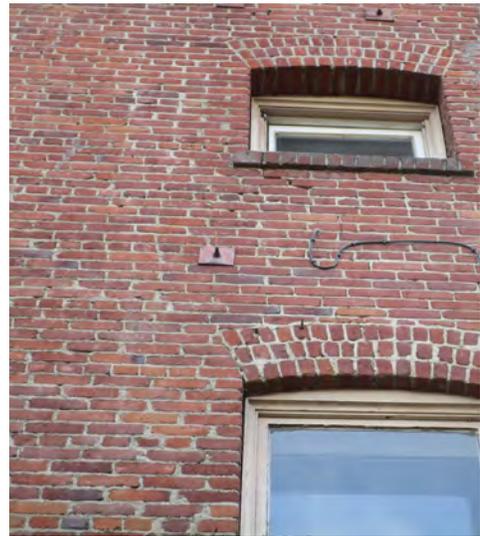
An example of seismic anchor plates that blend in with the surrounding brick.

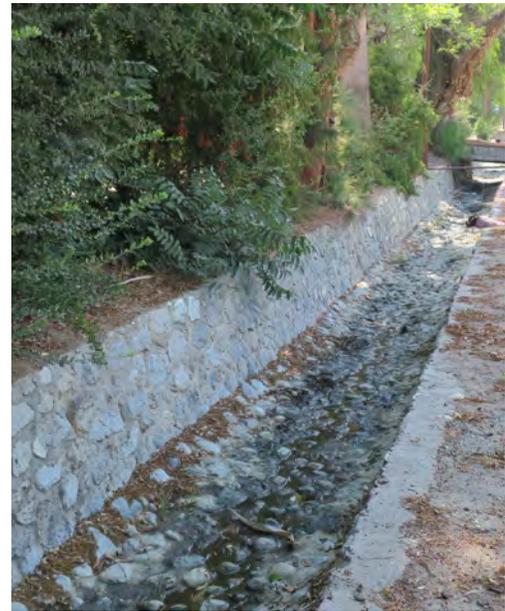
Stone-lined ditches and culverts are found throughout Redlands.
