GEOTECHNICAL ENGINEERING INVESTIGATION
THE NEIGHBORHOODS AT LUGONIA VILLAGE
NORTHWEST CORNER OF WEST LUGONIA AVENUE
AND KARON STREET
REDLANDS, CALIFORNIA
Project Number: H02901.01

**Subject: Geotechnical Engineering Investigation
 The Neighborhoods at Lugonia Village
 Northwest Corner of West Lugonia Avenue and Karon Street
 Redlands, California**

**Geotechnical Engineering Investigation
The Neighborhoods at Lugonia Village
NWC of West Lugonia Avenue and Karon Street, Redlands, California
February 11, 2022**

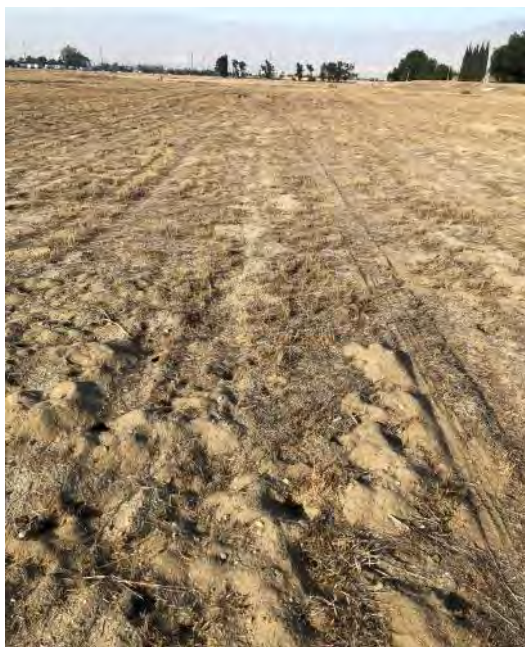
Photograph No. 3: Viewing north along east side of site; small rodent burrows in foreground

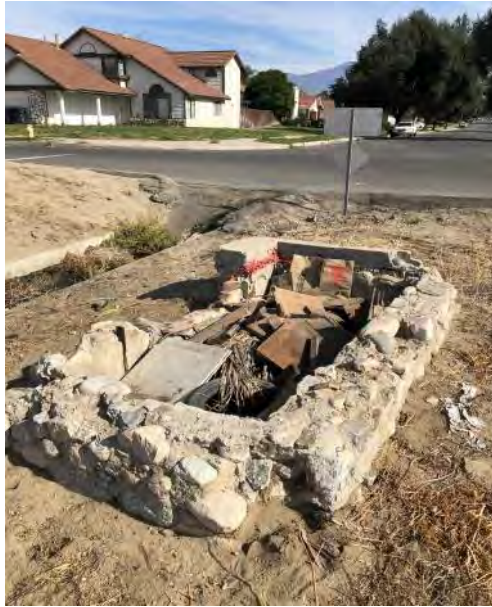
Photograph No. 5: Rectangular-shaped concrete structure filled with debris in northeast corner of site near the intersection of Karon Street and Pennsylvania Avenue

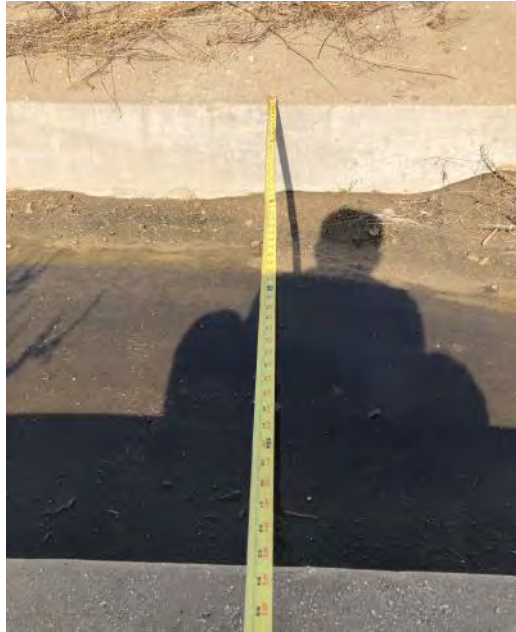
Photograph No. 7: U-shaped concrete structure trending east-west along center line of future extension of Pennsylvania Avenue is about 4.5 feet wide and 12 inches in height

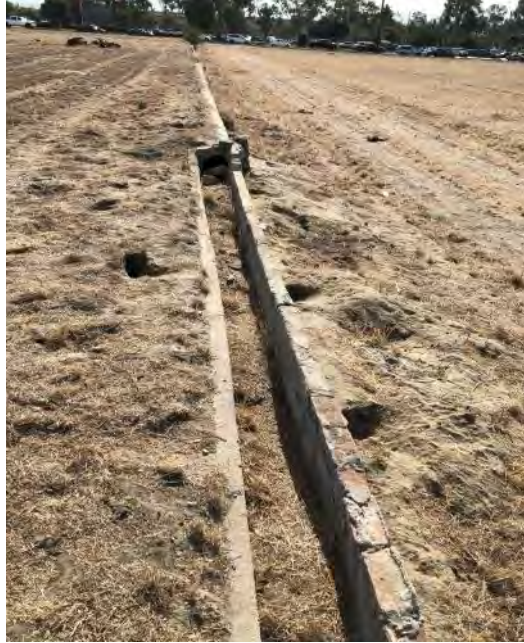
Photograph No. 9: Viewing south along west side of site showing concrete drainage structure (U-shaped structure in foreground and circular concrete pipe in background)

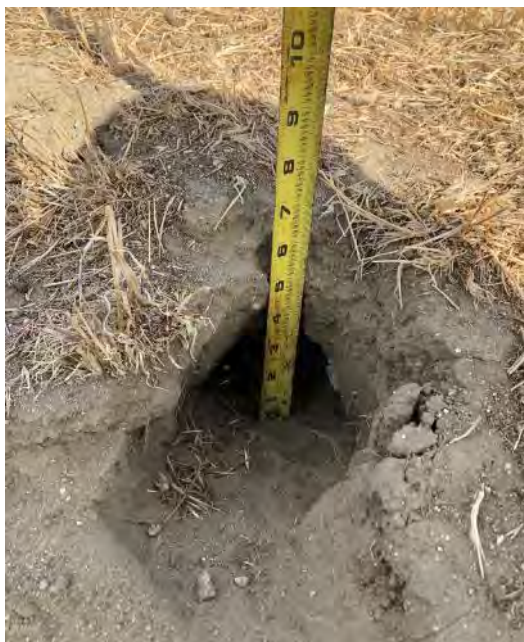
Photograph No. 11: Seven-inch deep rodent burrow on west side of site

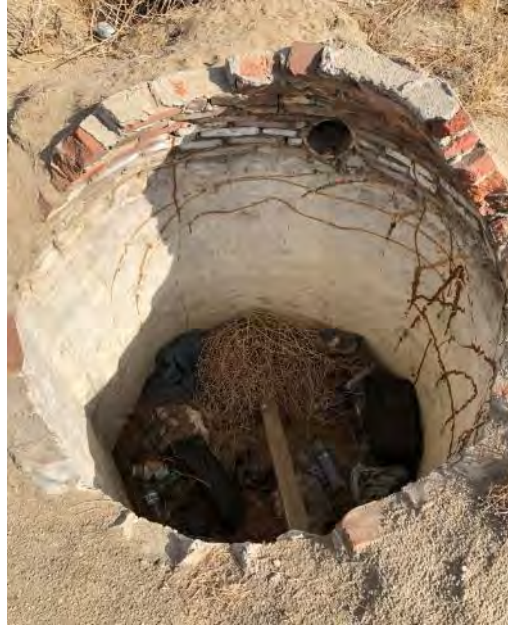
Photograph No. 13: Open cylindrical excavation (shaft) made of brick, concrete and filled with debris in the southwest portion of the site
