## ATTACHMENT "B"

Santa Fe Depot Historic District National Register Form

### **Architectural Plans**

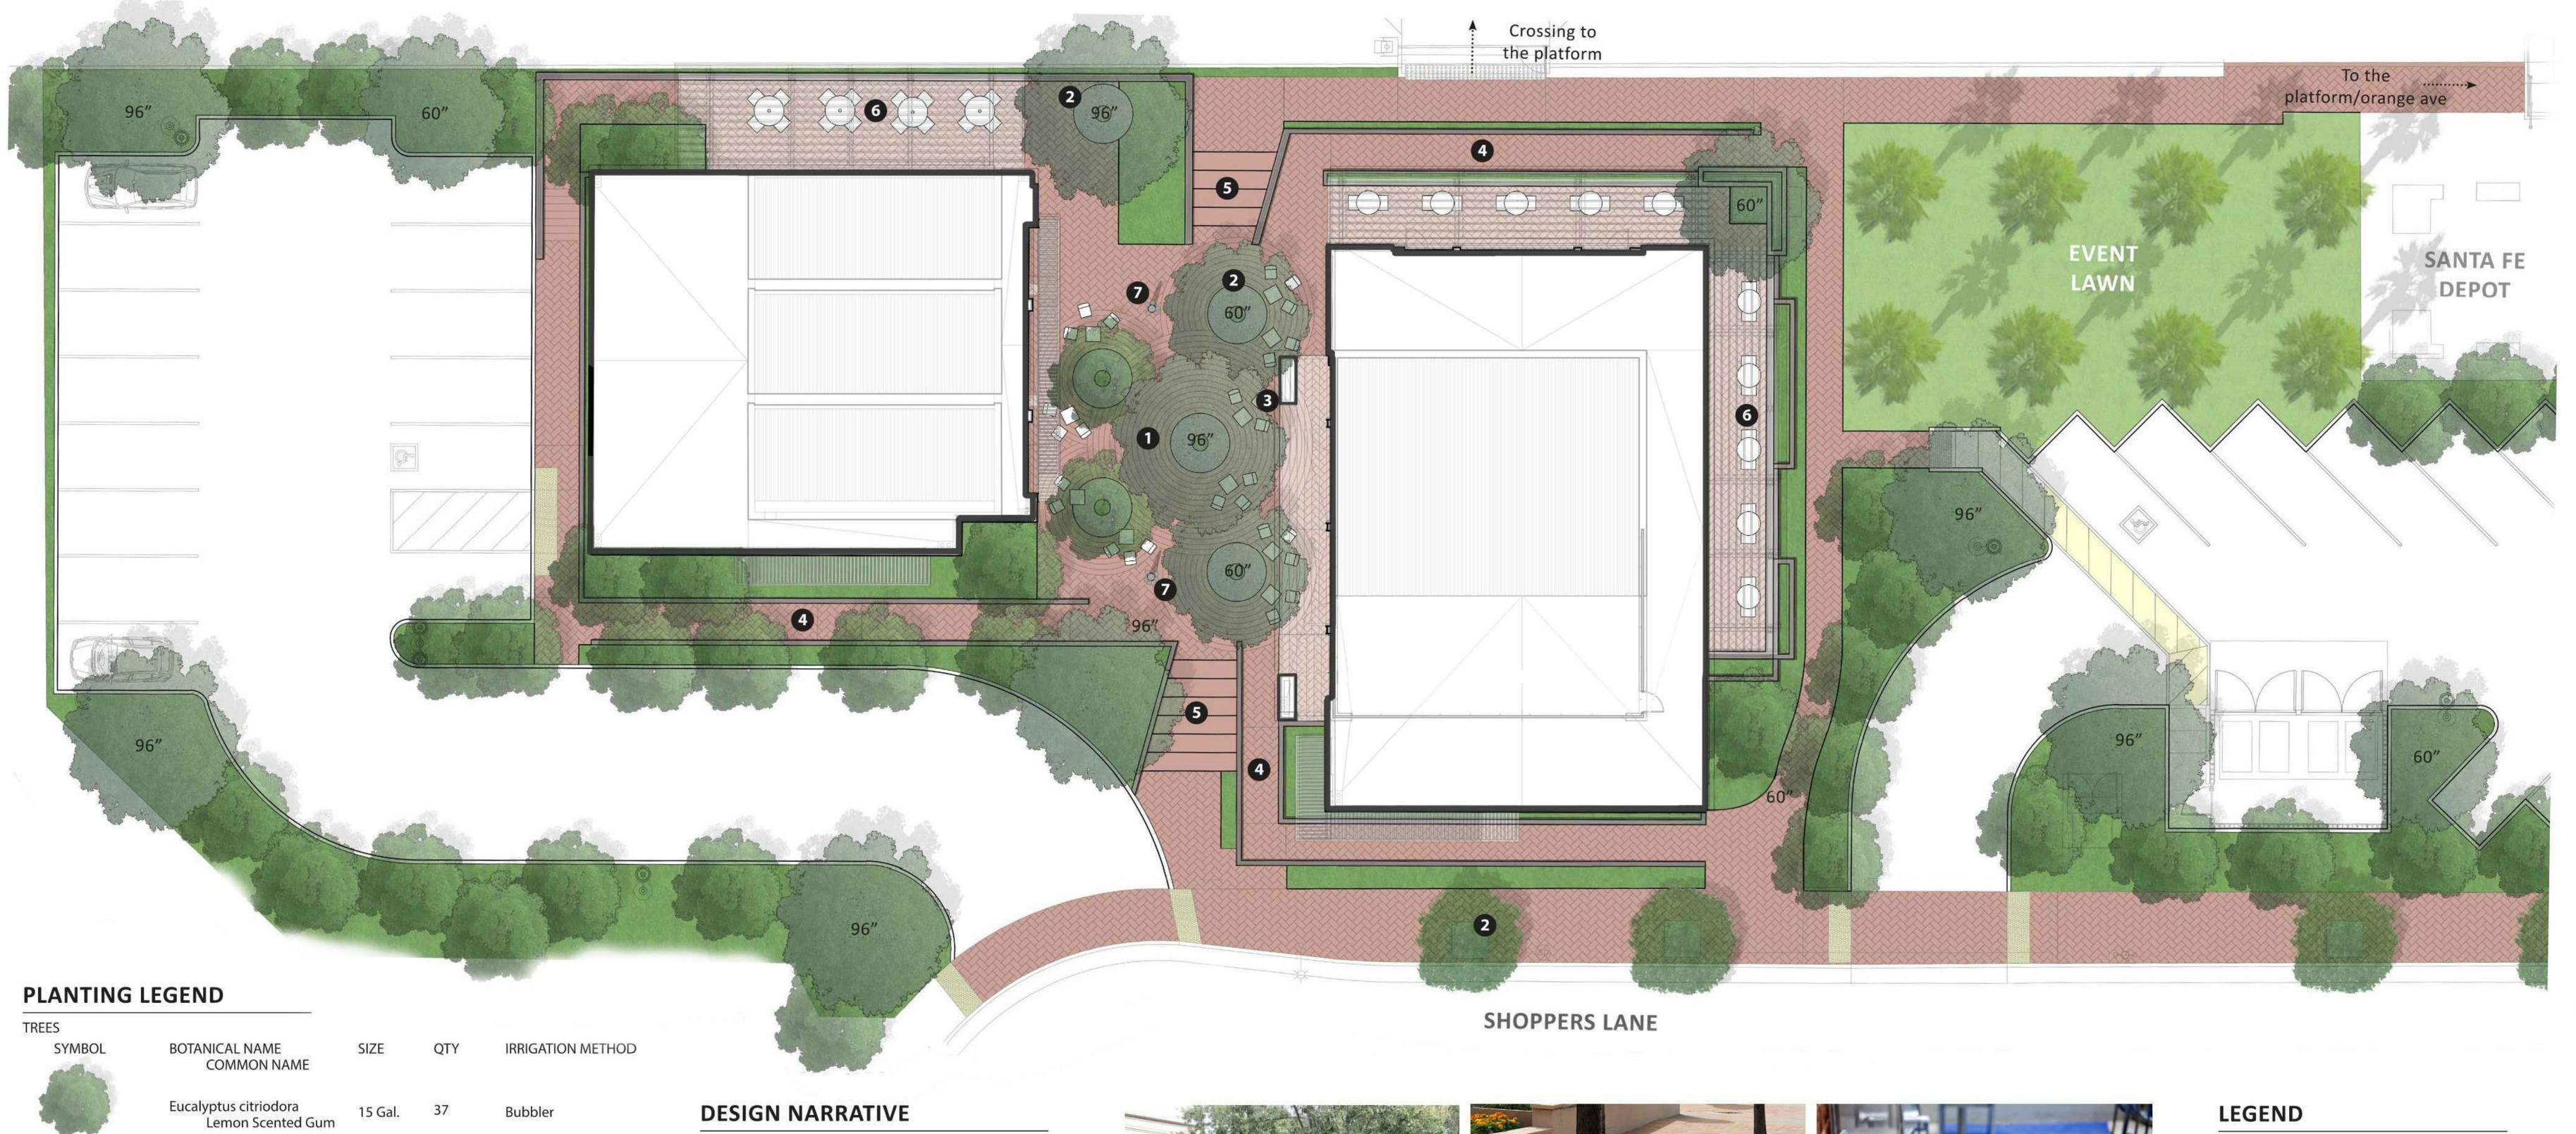
The event lawn celebrates the Santa Fe Depot with palms strategically placed to follow the cadance of the Santa Fe Depot's structural columns.

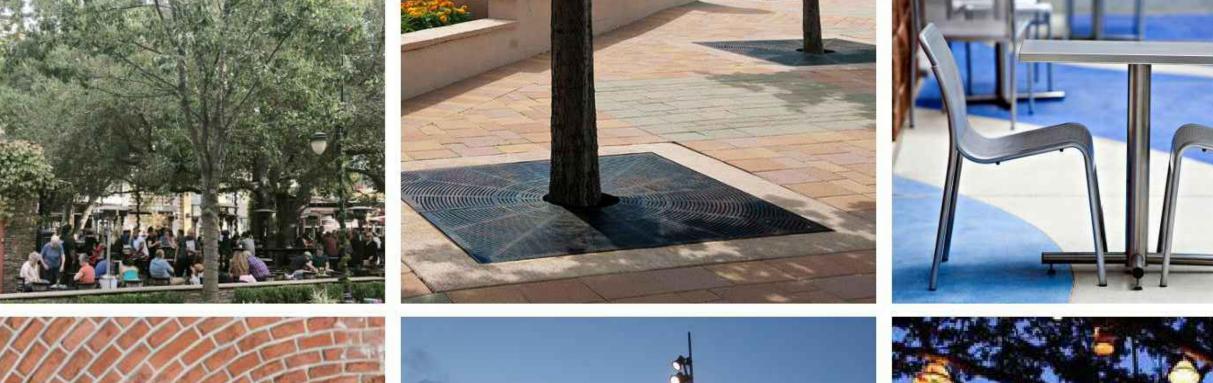
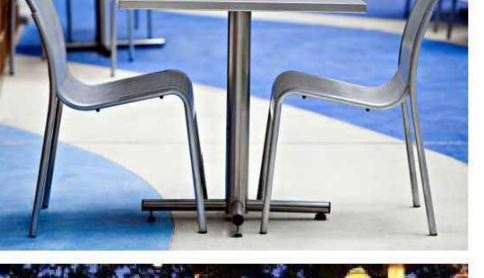
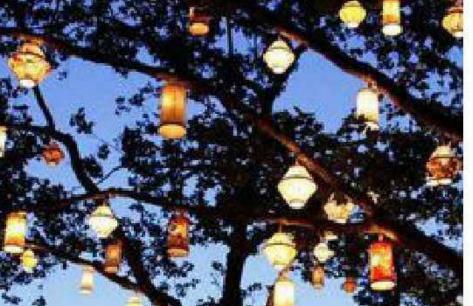
- MAIN BRICK TERRACE
- 2 TREE WITH GRATE
- 3 MOVABLE CHAIRS AND TABLES
- 4 ADA RAMP
- 5 ENTRY STAIRS
- 6 PATIO SEATING
- EVENT POLE LIGHTING

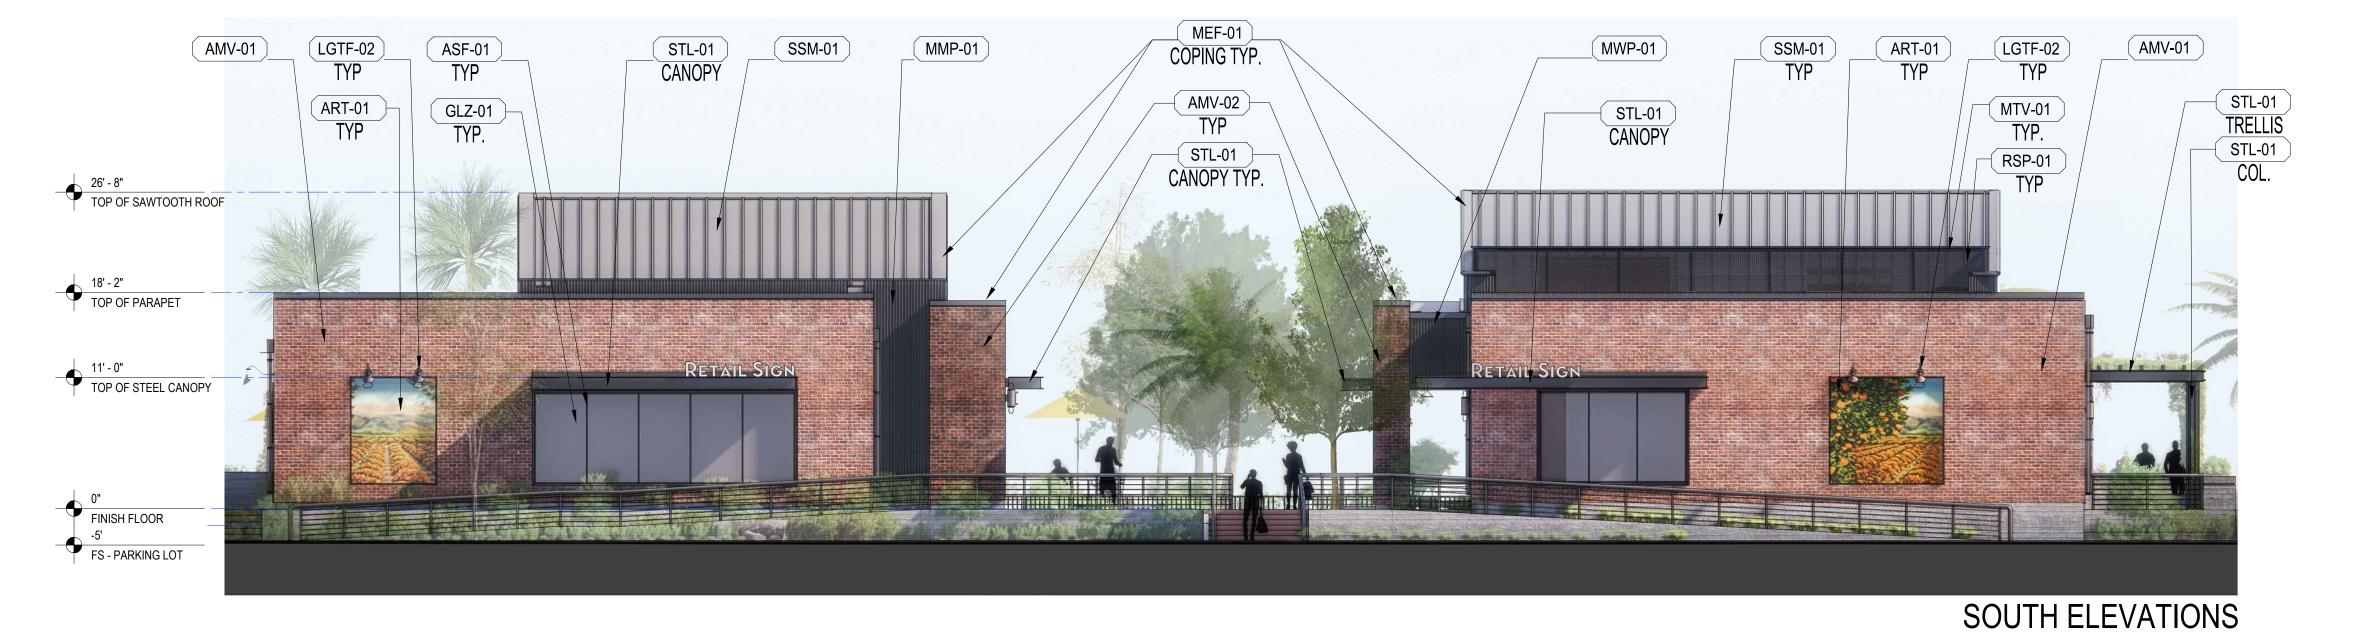
MEF-01 COPING TYP. ASF-01 TYP STL-01 CANOPY TYP. TRELLIS
STL-01
COL. GLZ-01 TYP. HRL-01 TYP RLG-01 TYP LGTF-01 TYP STL-01 CANOPY TYP. STL-01 ST. FRAME TYP. TOP OF SHED ROOF 18' - 2"
TOP OF PARAPET 12' - 0"
TOP OF STEEL PERGOLA WEST BUILDING EAST ELEVATION

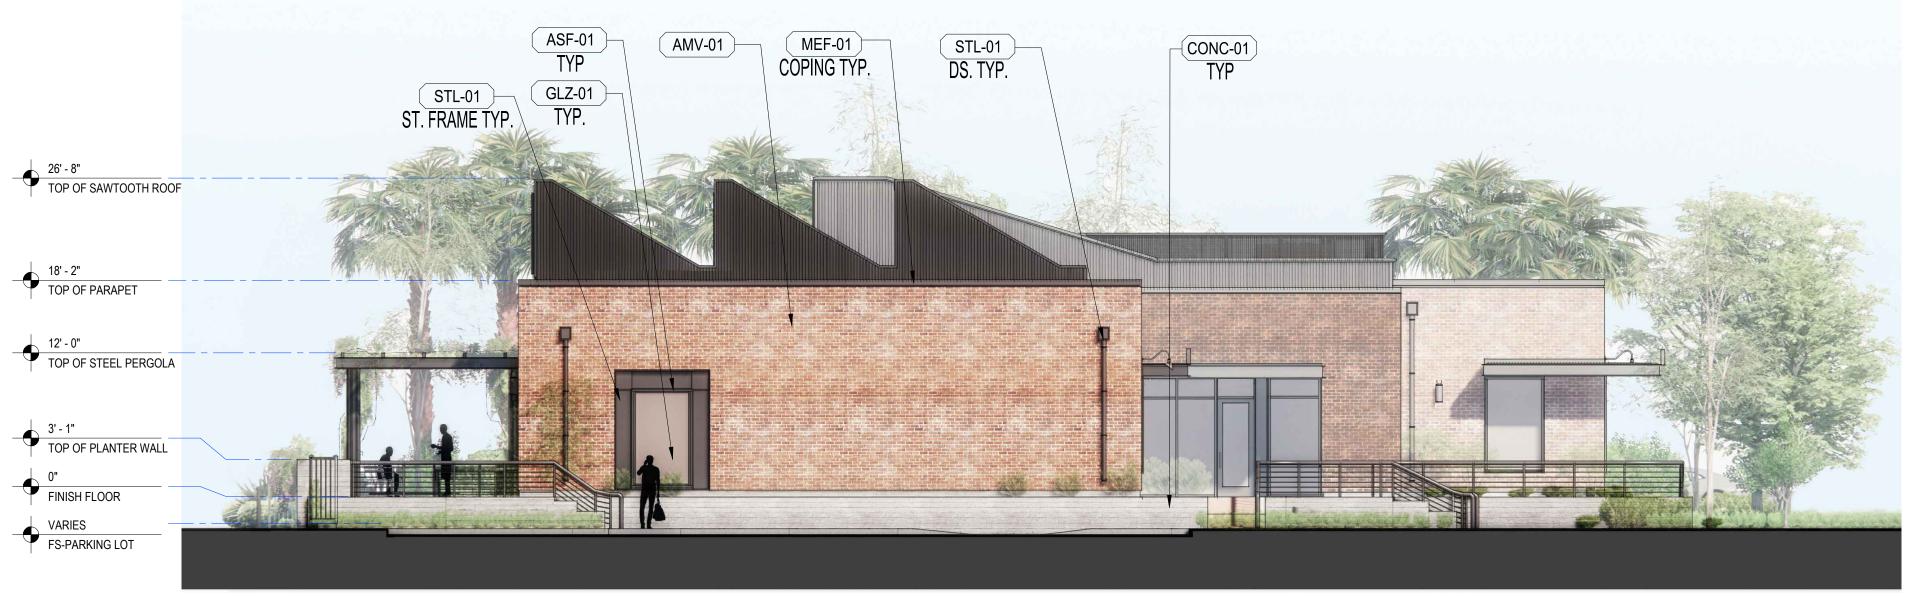
STL-01 ST. FRAME TYP. ASF-01 TYP GLZ-01 TYP. STL-01 COL. STL-01 PERGOLA MEF-01 COPING TYP. AMV-02 TYP HRL-01 TYP RLG-01 TYP RAG-01 ROOF ACCESS 26' - 8"

TOP OF SHED ROOF 18' - 2"
TOP OF PARAPET 12' - 0"
TOP OF STEEL PERGOLA 0" FINISH FLOOR VARIES PARKING LOT
