Redlands Historic Architectural Design Guidelines

City of Redlands, CA

Architectural Resources Group

01/25/24

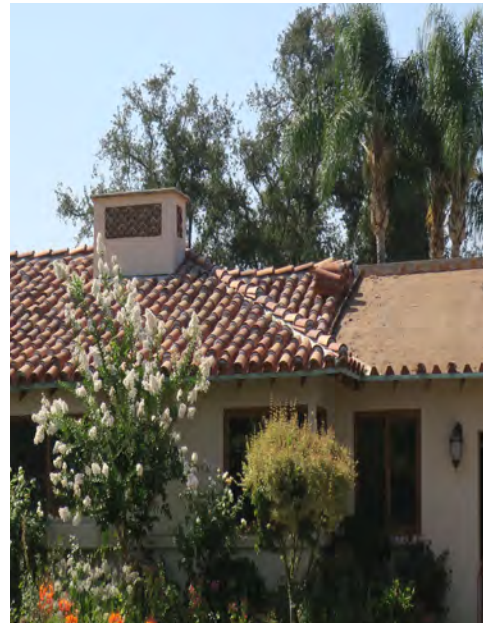
New roof tiles or shingles should match the material, size, profile, and color of the historic roof as closely as possible.

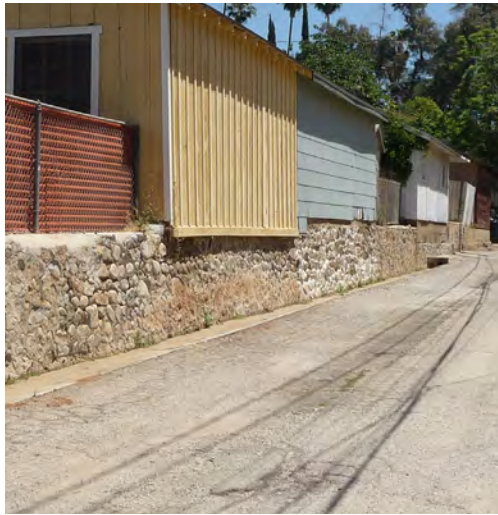
Arroyo stone foundations are an important architectural feature of many historic houses in Redlands and should be preserved.

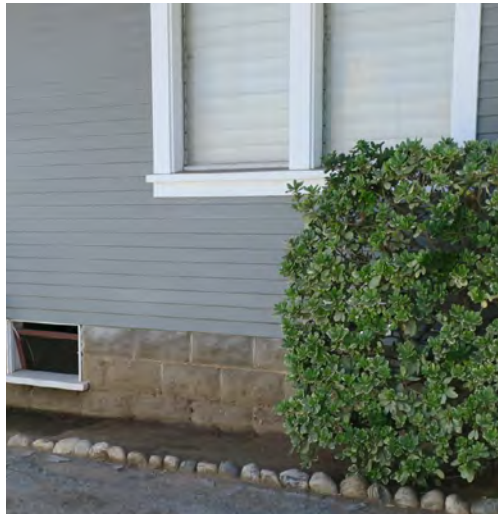
Routine maintenance, such as cleaning and repointing, is important to prolong the life of a historic foundation.

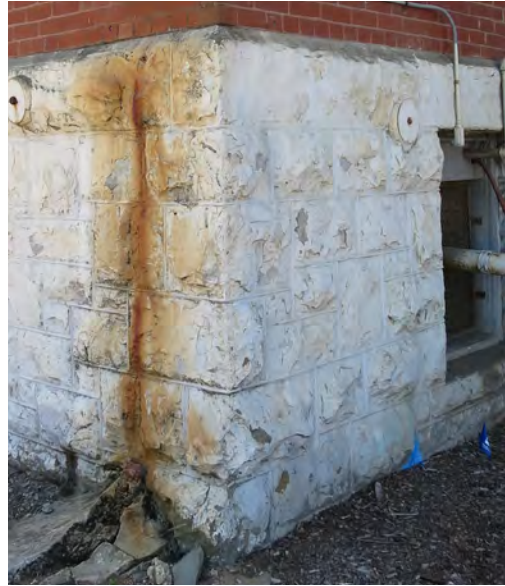
A cast stone foundation that is in need of repair.

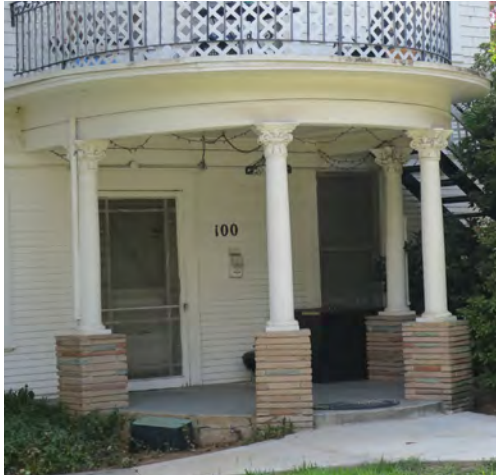
Restore non-historic porch components, such as these piers supporting original porch columns, to their original condition.

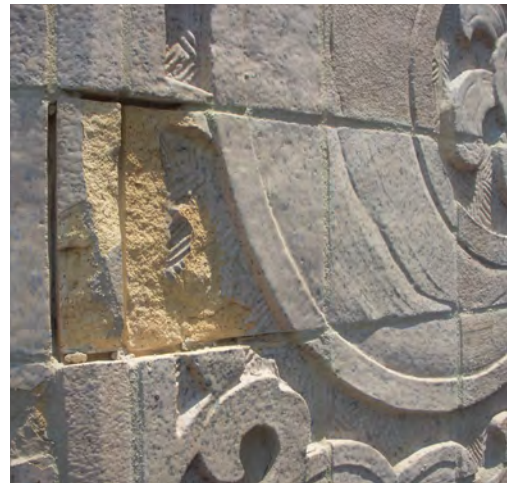
Damaged terra cotta detail.

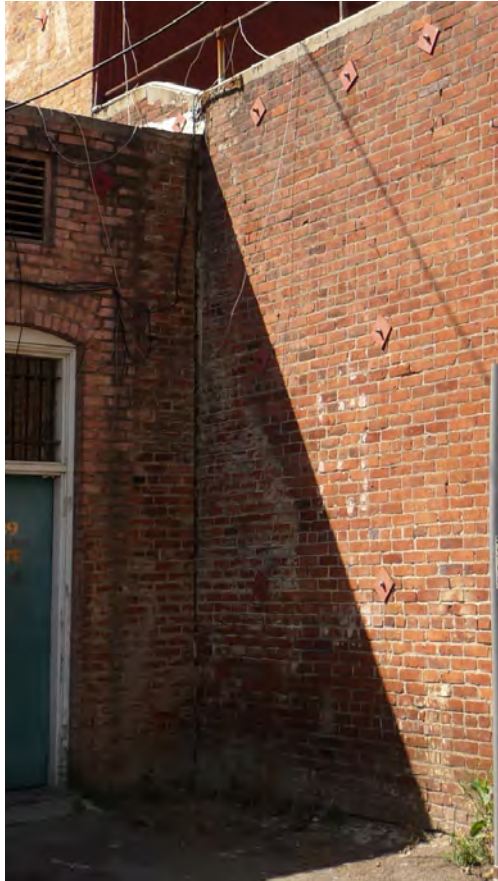
Efflorescence on a historic brick wall.

Efflorescence is water-soluble salts that have leached out of the masonry, evaporated, and deposited on the surface, usually as a white, powdery substance. The salt crystals expand as the water is evaporated, leading to surface damage, and in some cases, sub-surface damage (sub-florescence).

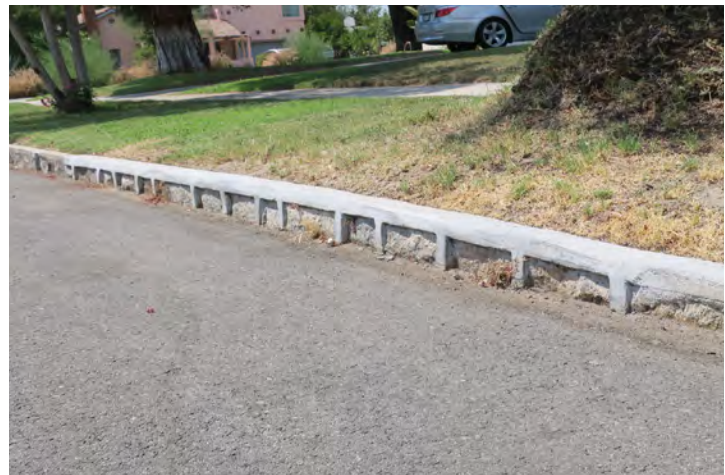
Inappropriate concrete repairs to cut stone curbing.

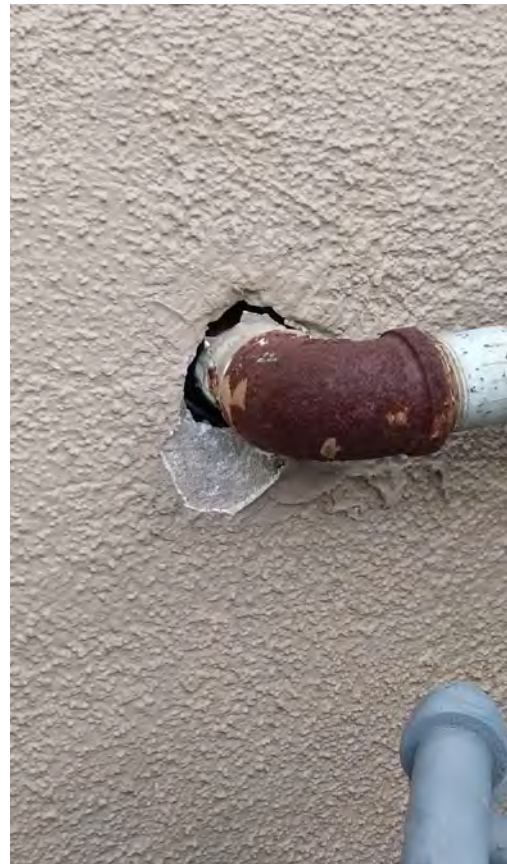
Void and spalling around stucco wall pipe intrusion.

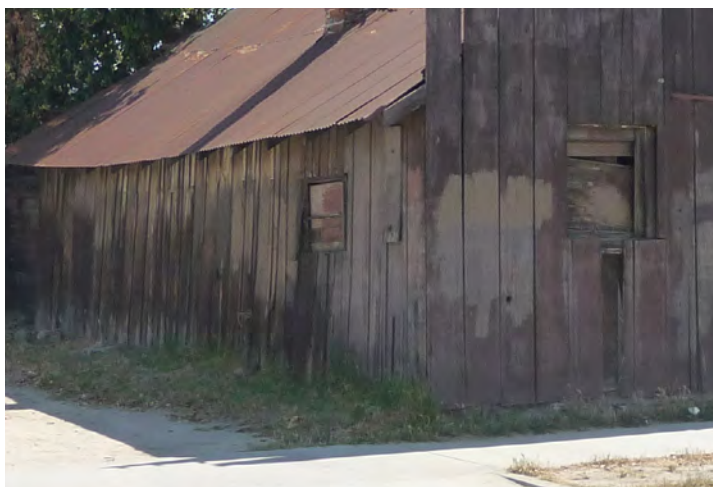
Direct contact with the ground can lead to wood decay.

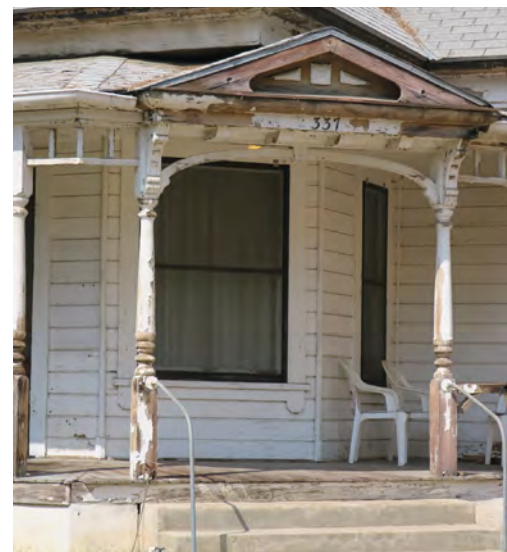
Deteriorated woodwork at a porch.

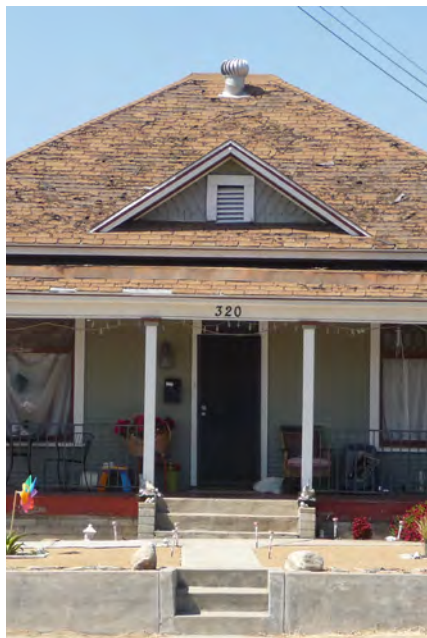
Deteriorated asphalt shingle roofing on the former Harbert Residence (1907).

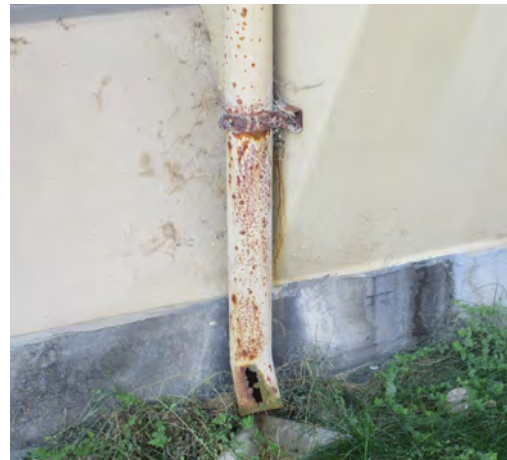
Corroded downspout.

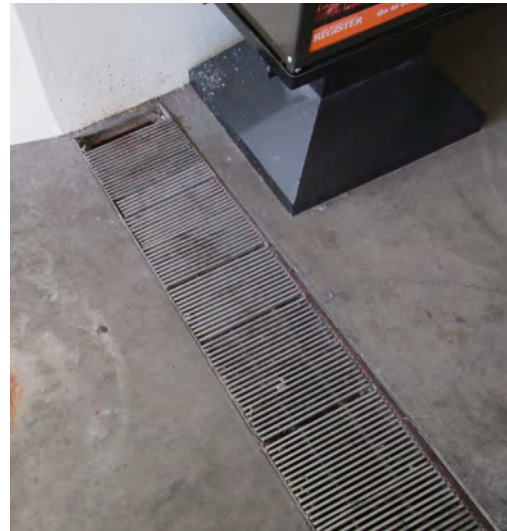
Drain with uneven grate panels.

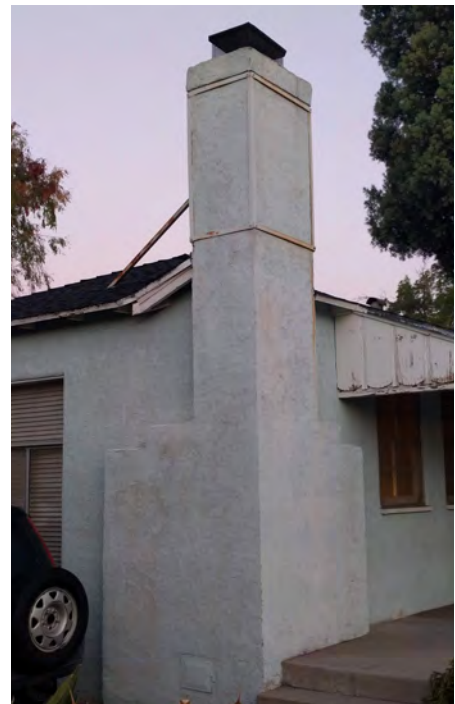
Brace or reinforce chimneys.

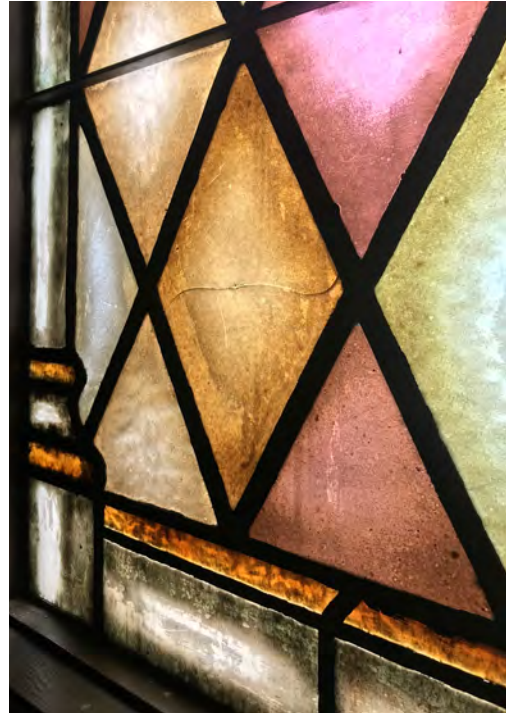
Cracked glazing in a stained glass window.

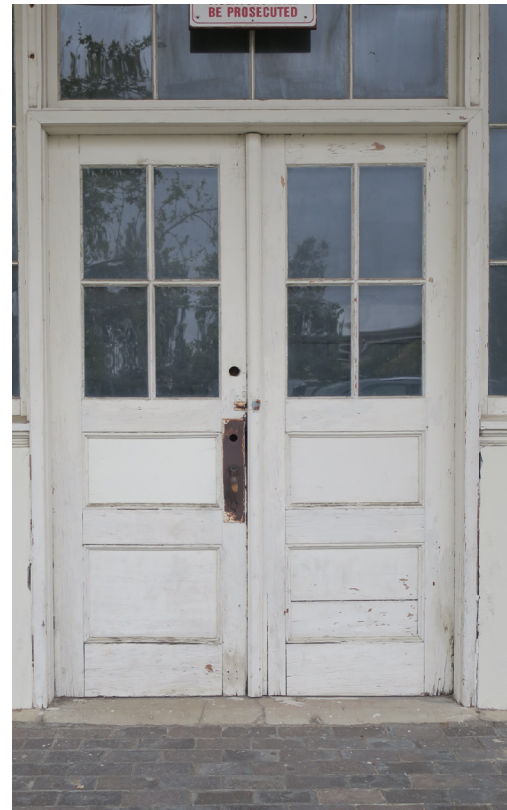
Weathered doors with corroded and missing hardware.

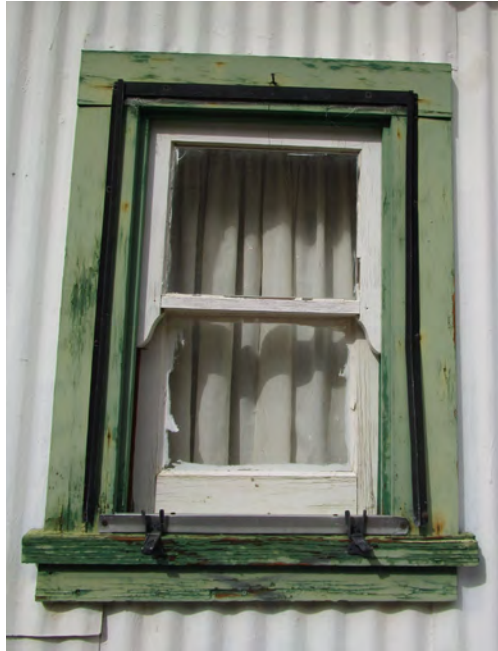
Weathered and racked window needing repair.

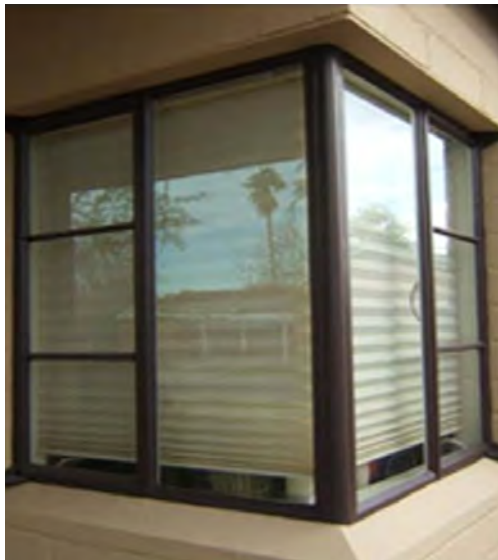
Retrofitting original windows with historically compatible, low-e glass is a way to achieve greater energy efficiency. (Photo, City of Phoenix Planning and Development Department, Historic Preservation Office, 2018.)

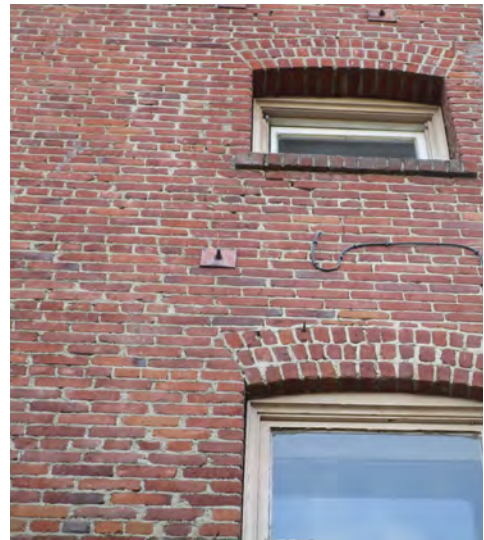
An example of seismic anchor plates that blend in with the surrounding brick.
