Redlands Historic Architectural Design Guidelines

City of Redlands, CA

Architectural Resources Group

10/26/18

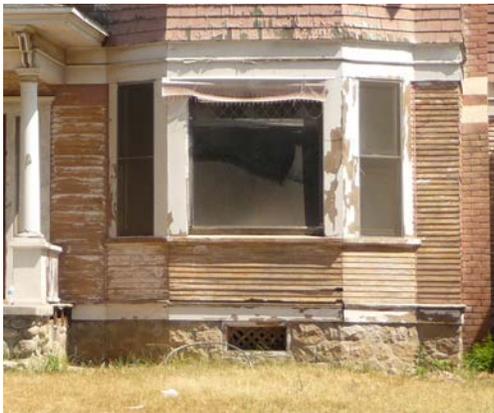
Repair historic windows when the physical condition warrants additional work.

- Repair a historic window when the physical condition warrants additional work.
- Repair work may include: replacing cracked or broken glass; patching, splicing, or consolidating elements such as the surround, frame, and muntins; or other treatments.
- Repair work may include the limited in-kind replacement of extensively deteriorated or missing window components.
- All repairs should be carried out to match an existing historic window in size, design, configuration, operation, materials, profiles, details, and finish.

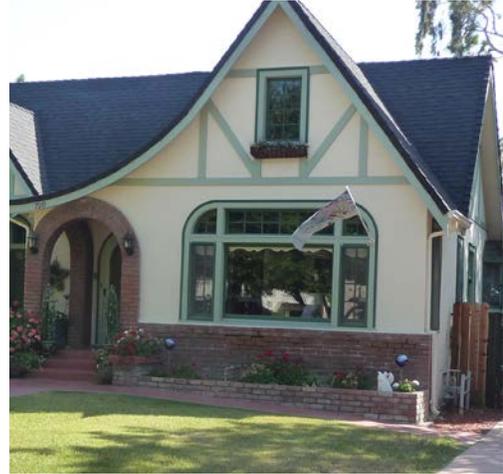
If window replacement is necessary, maintain the historic size, shape, and profiles of historic window openings.

- Replace a historic window only when it is deteriorated beyond repair.
- A replacement window should be replicated from an existing historic window to match the size, design, configuration, operation, materials, profiles, details, and finish.
- Match the exterior profiles and dimensions of the historic window as closely as possible. The original window opening and surround should not be altered to accommodate a larger or smaller window.
- Clear glazing should be replaced with clear glazing, and tinted glazing with tinted glazing, with transparency matching that of the historic glass. Consider replacing clear glass with clear low-e glazing.

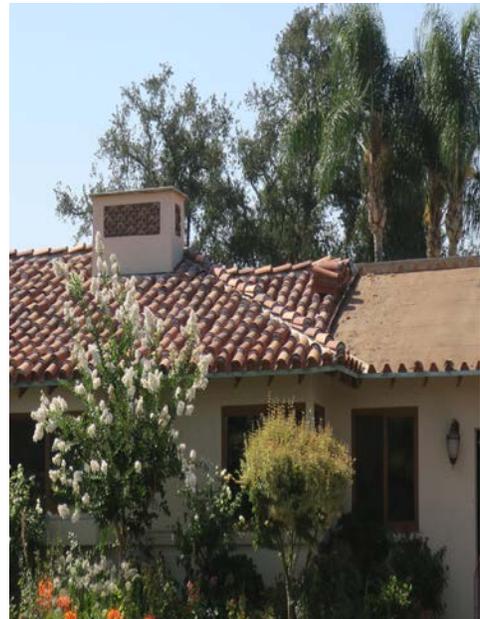
New roof tiles or shingles should match the material, size, profile, and color of the historic roof as closely as possible.

- Replace a historic roof only when it is deteriorated beyond repair.
- A replacement roof should match the existing historic roof in form, massing, materials, profiles, color, and details. The reinstallation of any salvageable tiles or shingles along with the new should be prioritized.

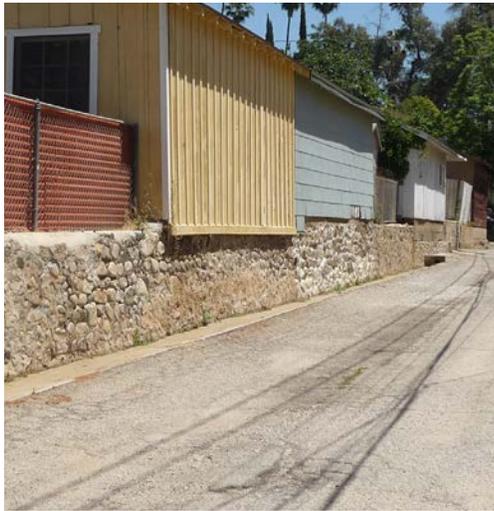
Arroyo stone foundations are an important architectural feature of many historic houses in Redlands and should be preserved.

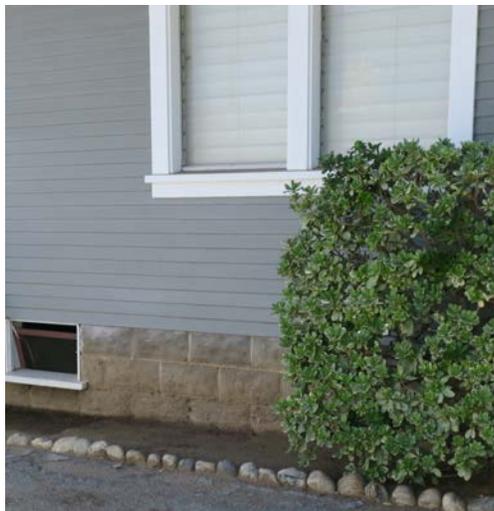
Routine maintenance, such as cleaning and repointing, is important to prolong the life of a historic foundation.

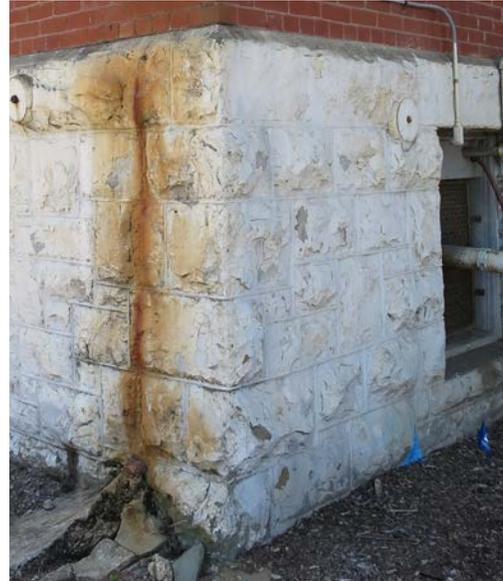
A cast stone foundation that is in need of repair.

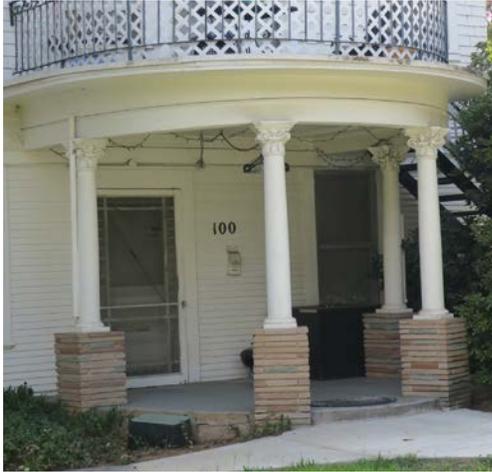
Restore non-historic porch components, such as these piers supporting original porch columns, to their original condition.

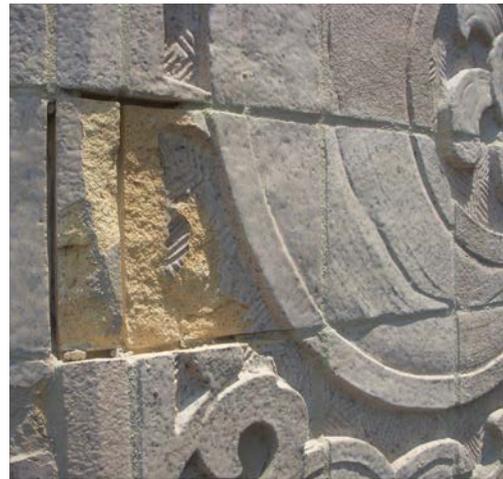
Damaged terra cotta detail.

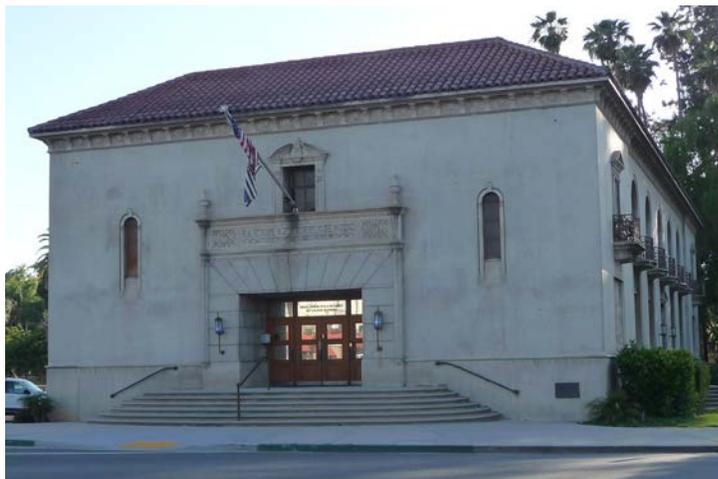
Redlands' former City Hall (1941) features concrete cladding and details.

Concrete is a mixture of fine aggregate (sand), coarse aggregate (gravel, crushed stone, or other coarse material), a binding agent (typically Portland cement since the early 1900s), and water. Concrete can either be cast in place, where it is poured, molded, and cured on site, or it can be precast off site. The introduction of reinforcement (metal bars/rods) in concrete in the mid- to late 19th century substantially increased the range, size, and types of buildings that could be constructed with the material. Concrete is extremely versatile, used for structural as well as ornamental purposes. Cast stone is a form of ornamental concrete or concrete veneer that is molded and sometimes pigmented to resemble a variety of natural building stones.

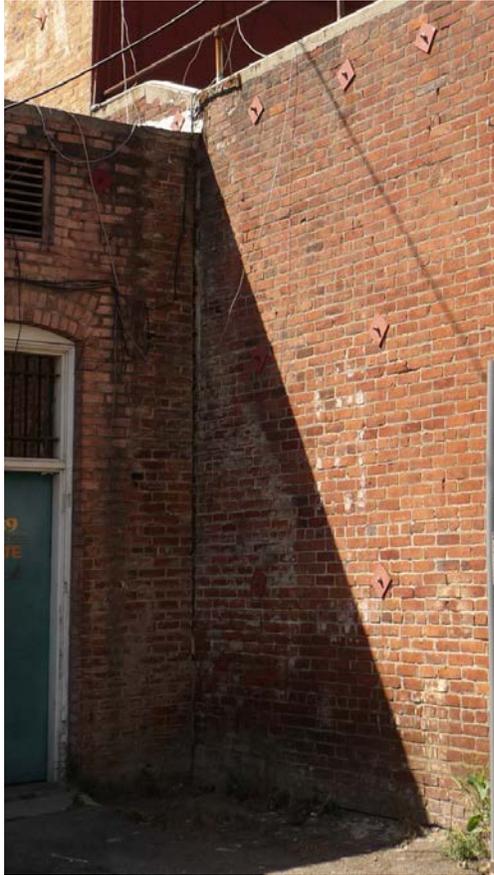
Efflorescence on a historic brick wall.

Efflorescence is water-soluble salts that have leached out of the masonry, evaporated, and deposited on the surface, usually as a white, powdery substance. The salt crystals expand as the water is evaporated, leading to surface damage, and in some cases, sub-surface damage (sub-florescence).

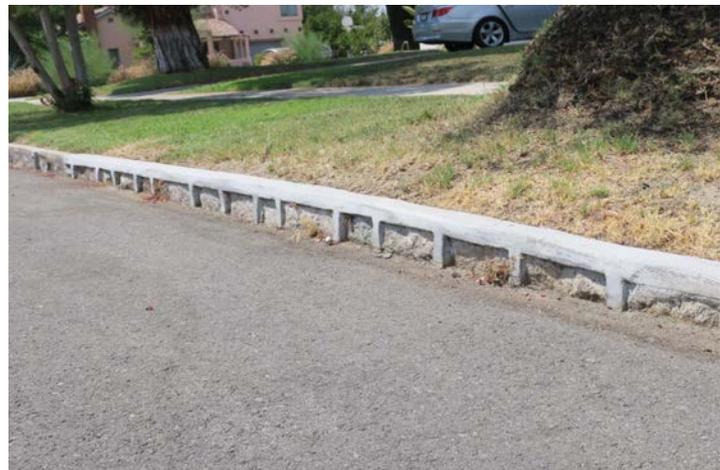
Inappropriate concrete repairs to cut stone curbing.

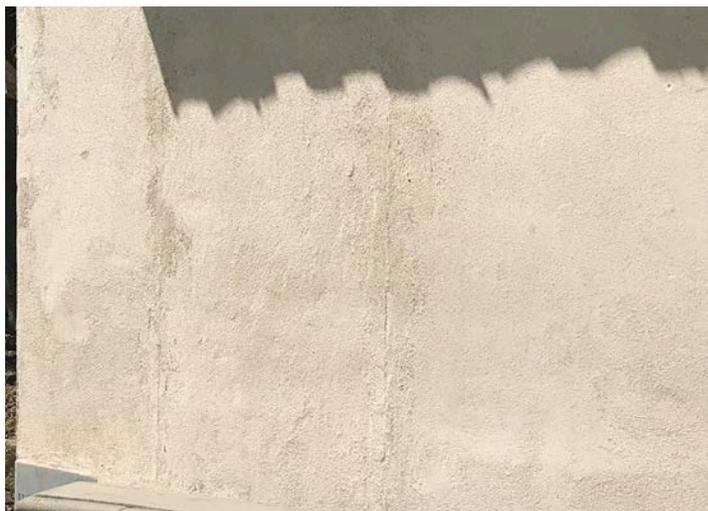
Incompatible stucco at an infilled door.

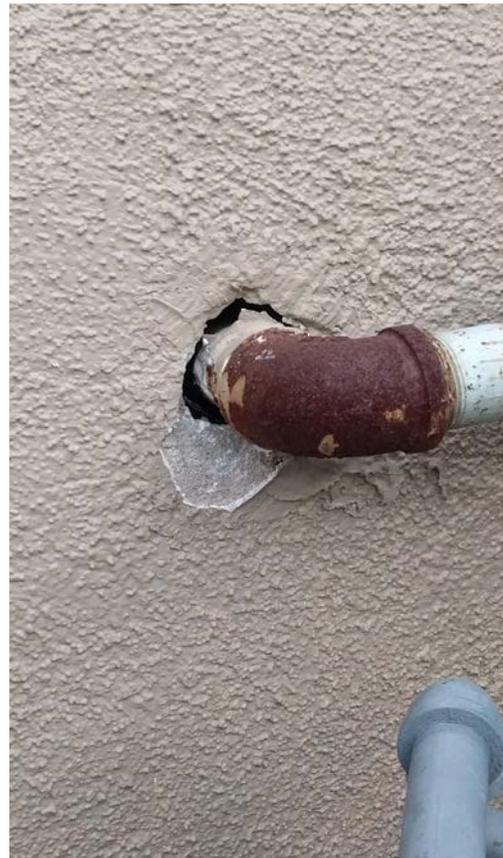
Void and spalling around stucco wall pipe intrusion.

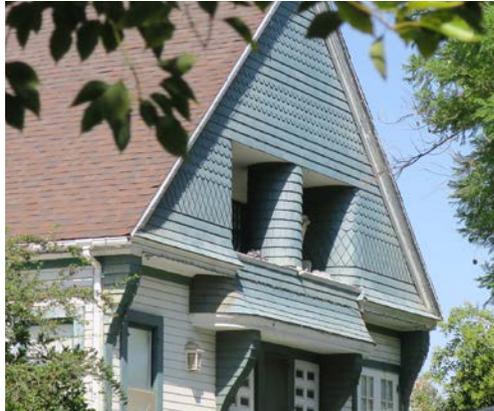
Wood shingle wall cladding.

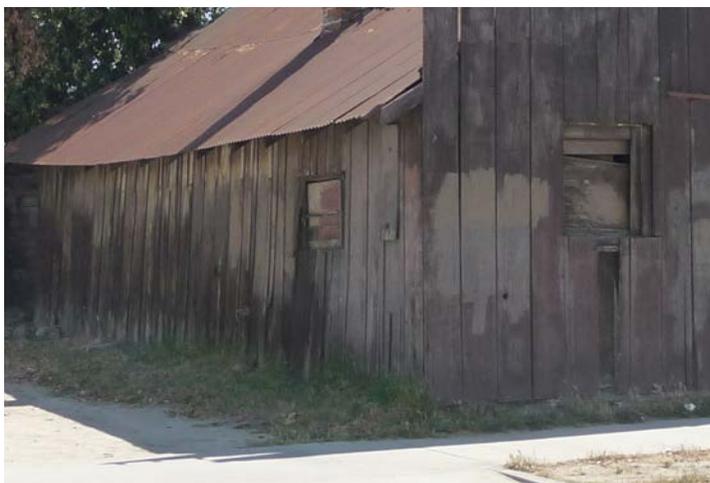
Direct contact with the ground can lead to wood decay.

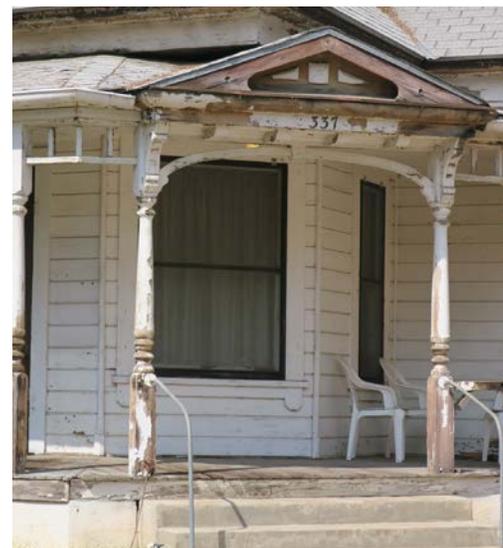
Deteriorated woodwork at a porch.

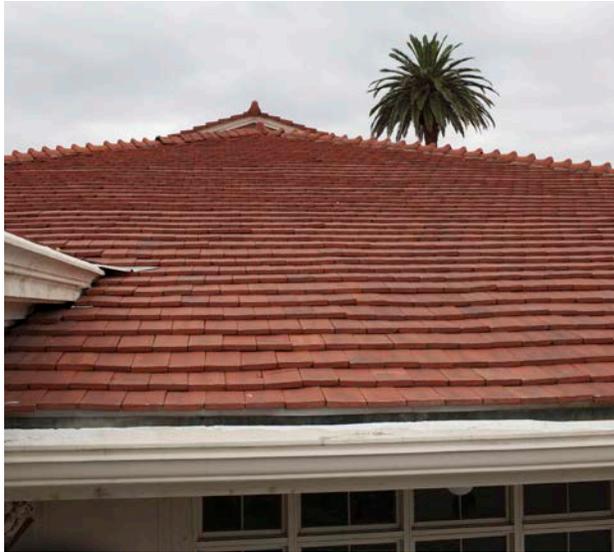
Clay tile (terra cotta) roofing on the Santa Fe Depot.

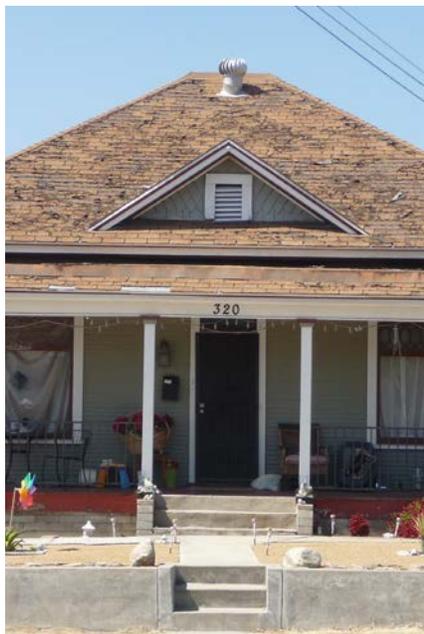
Deteriorated asphalt shingle roofing on the former Harbert Residence (1907).

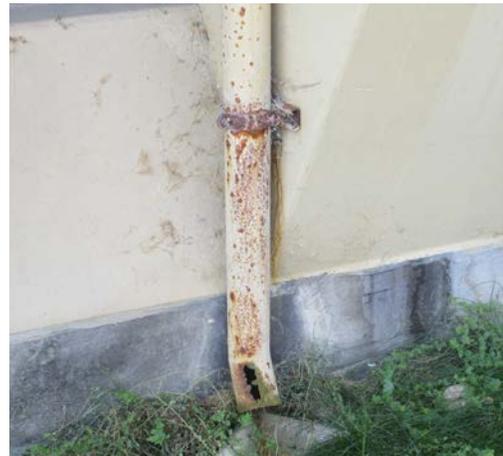
Corroded downspout.

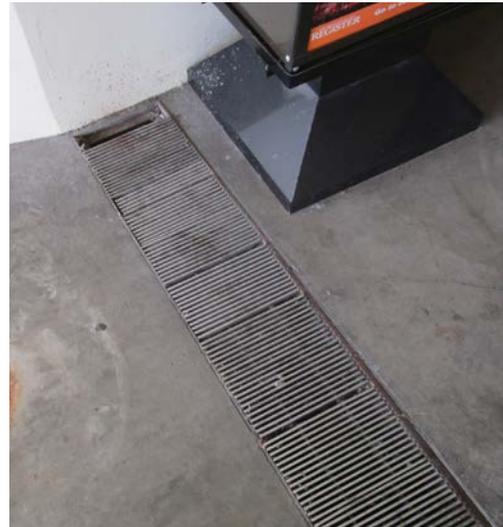
Drain with uneven grate panels.

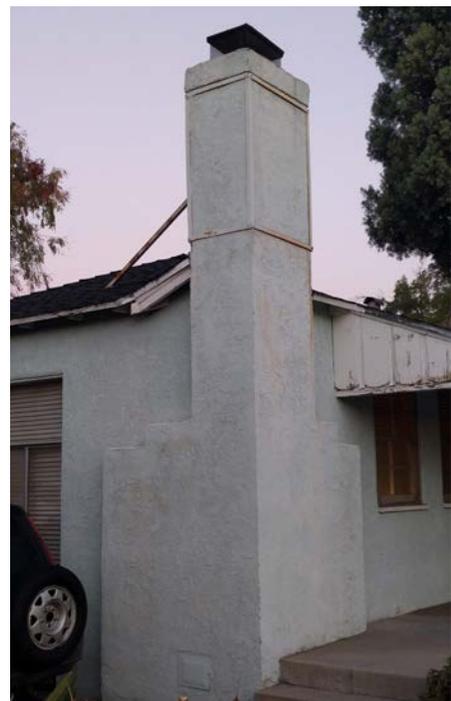
Brace or reinforce chimneys.

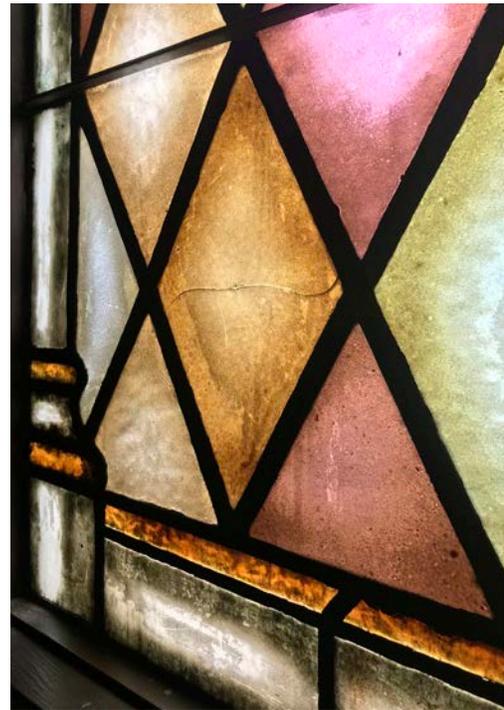
Cracked glazing in a stained glass window.

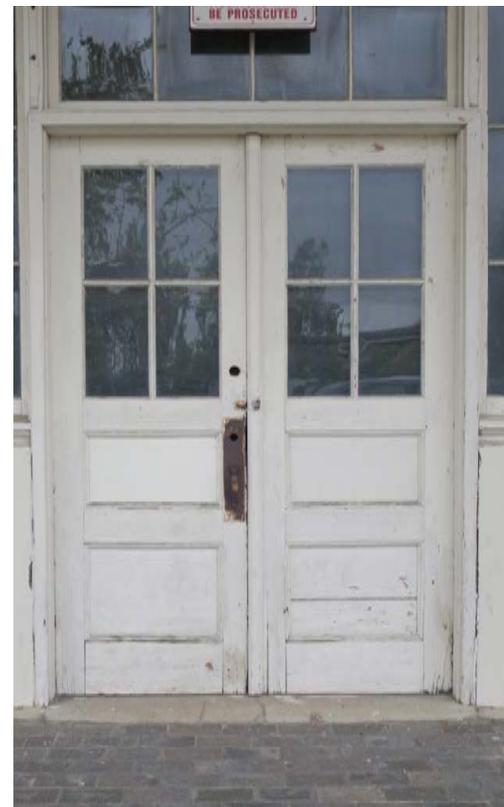
Weathered doors with corroded and missing hardware.

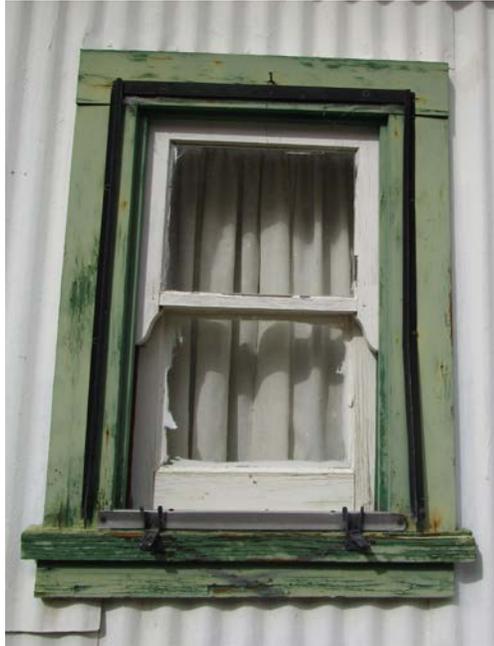
Weathered and racked window needing repair.

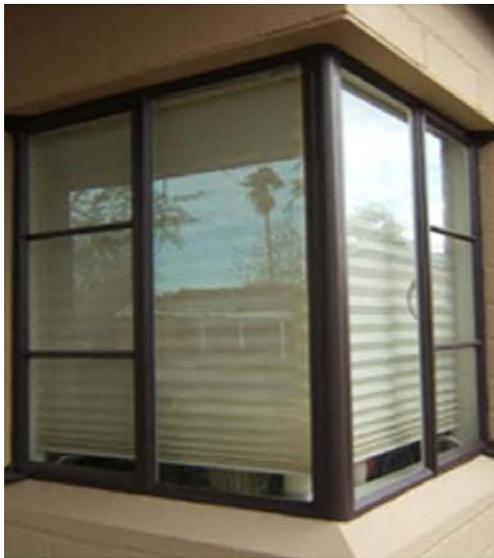
Retrofitting original windows with historically compatible, low-e glass is a way to achieve greater energy efficiency. (Photo, City of Phoenix Planning and Development Department, Historic Preservation Office, 2018.)

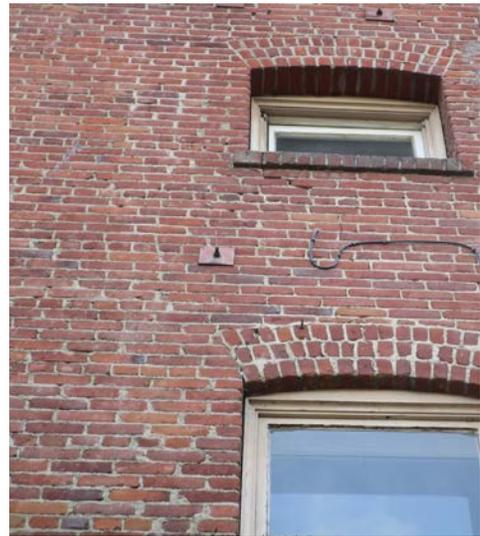
An example of seismic anchor plates that blend in with the surrounding brick.

For more information regarding structural requirements in historic buildings, refer to the [2016 California Historical Building Code, California Code of Regulation, Title 24, Part 8](#).

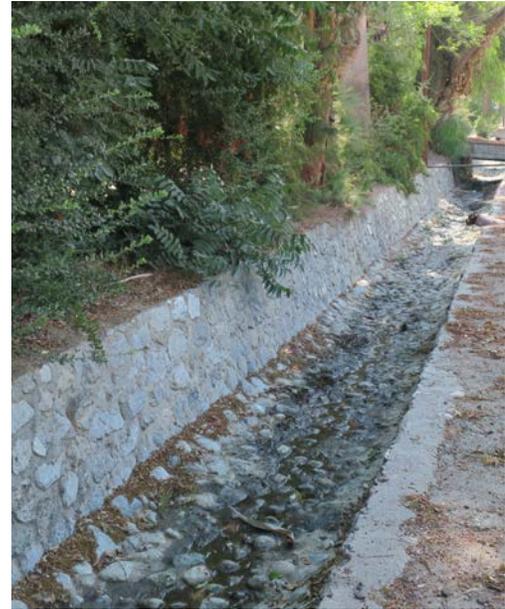
Stone-lined ditches and culverts are found throughout Redlands.
